# **Spatial Survey of Aquatic Plants in Charlie Lake on July 11, 2014**

Ministry of Forests, Lands, and Natural Resources Operations

Charlie Lake Conservation Society

July 2014

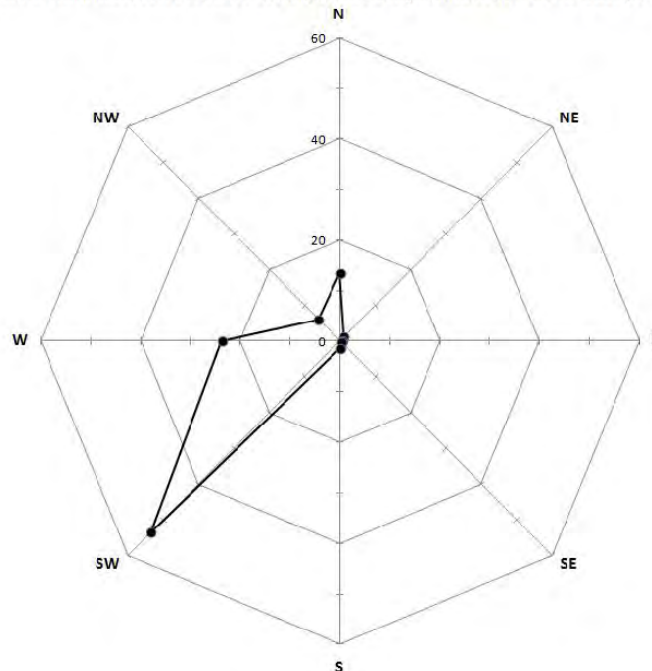
From these data we can construct a wind rose (see below), which is a graphical representation of the relative magnitude of wind direction.

Prevalent wind direction based on FSJ Airport monthly weather data 1942-2012 (% of total)

Weather data recorded at the Ft. St. John Airport, obtained from Environment Canada’s website for the summer periods from 1942 to 2012, indicates that the direction of maximum wind gusts, measured in 10 degree intervals from 0 to 360, is by far from a S.W. direction (53.5 % of the total), as shown in the table below:

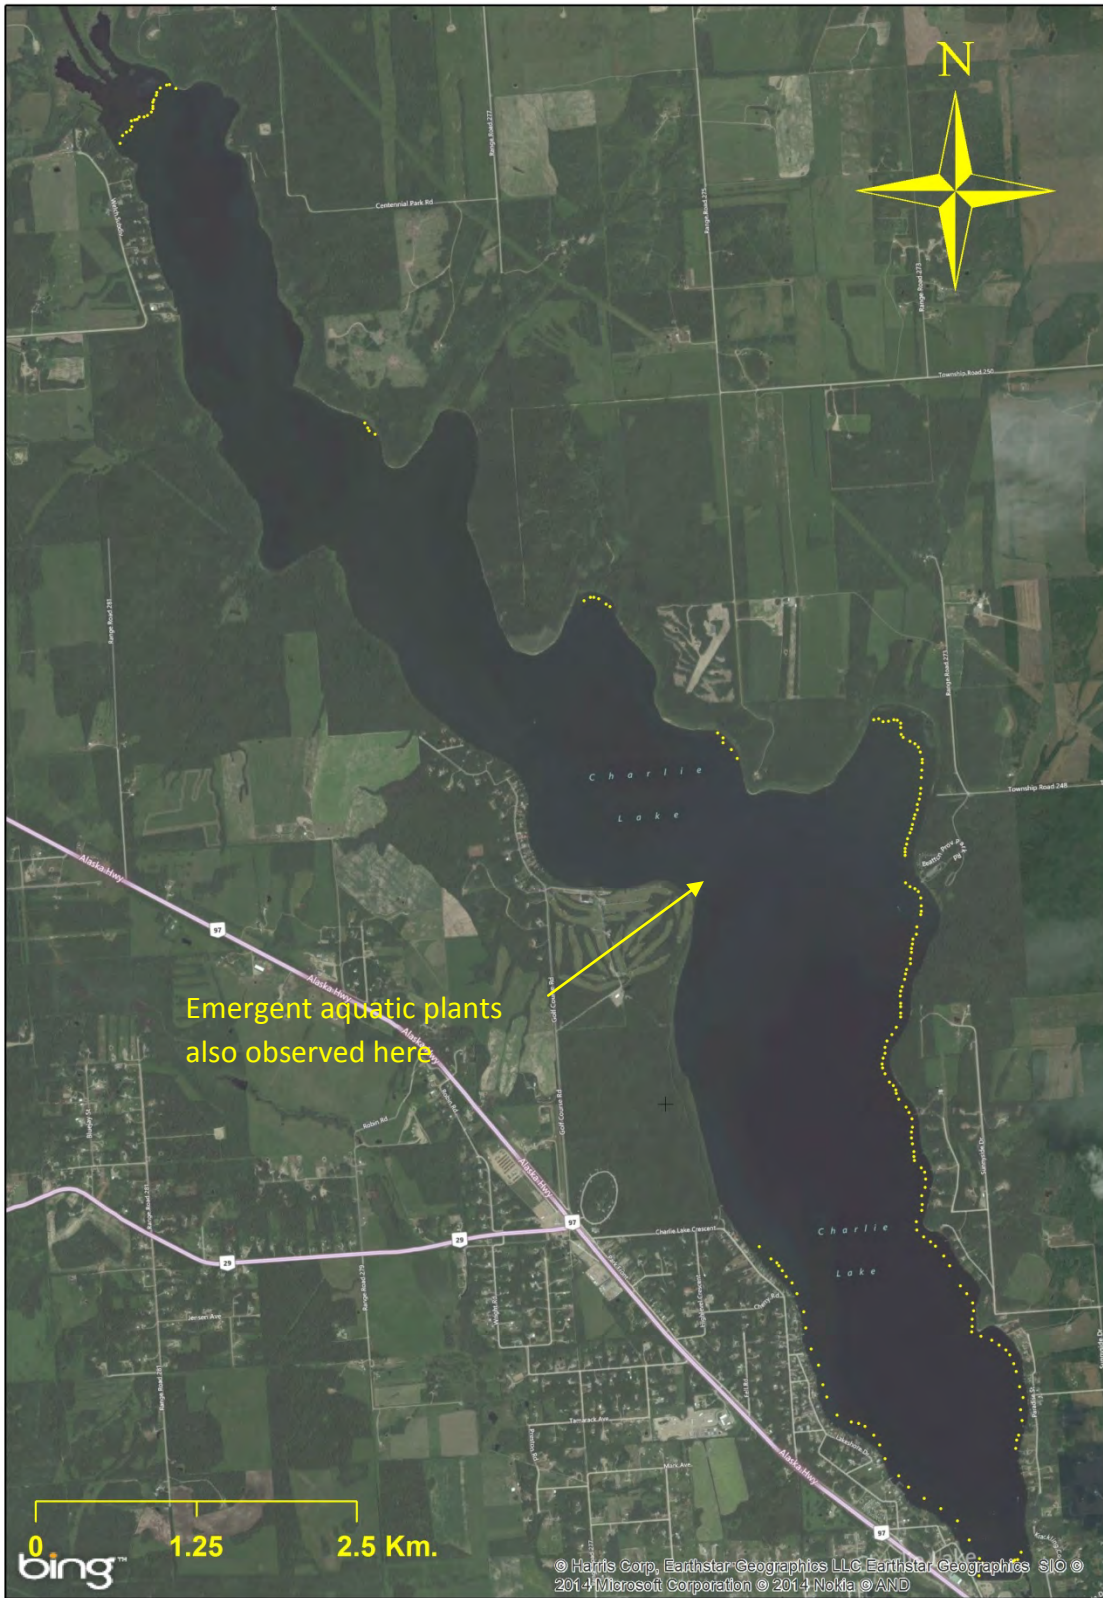
Figure 1: Map of Charlie Lake showing the edges of dense, emergent aquatic plants.

The conditions on the day of the survey were perfect, with sunny skies, negligible breeze and very good visibility. Water clarity was measured with a Secchi disc and the depth was 2.1 meters. After some trial and error on the best methodology, we found that the edge of the emergent plant beds was easily spotted because it created a buffer between rippled and still water. Starting at the south end of the lake, we drove the boat along the shore at slow speed, periodically marking waypoints on the GPS. No waypoints were recorded where there was no vegetation. The survey time ranged approximately from 09:30 to 14:00h PDT. The waypoints showing the edge of the aquatic plants are shown in Figure 1. One small additional patch of plants was observed near the Lakepoint Golf course after the survey was done, so no waypoints are recorded but it is indicated on the map. Figures 2 to 4 show zoomed-in areas of the lake. For comparative purposes, a map of aquatic plants distribution drawn by Bob Ohland pre-1980

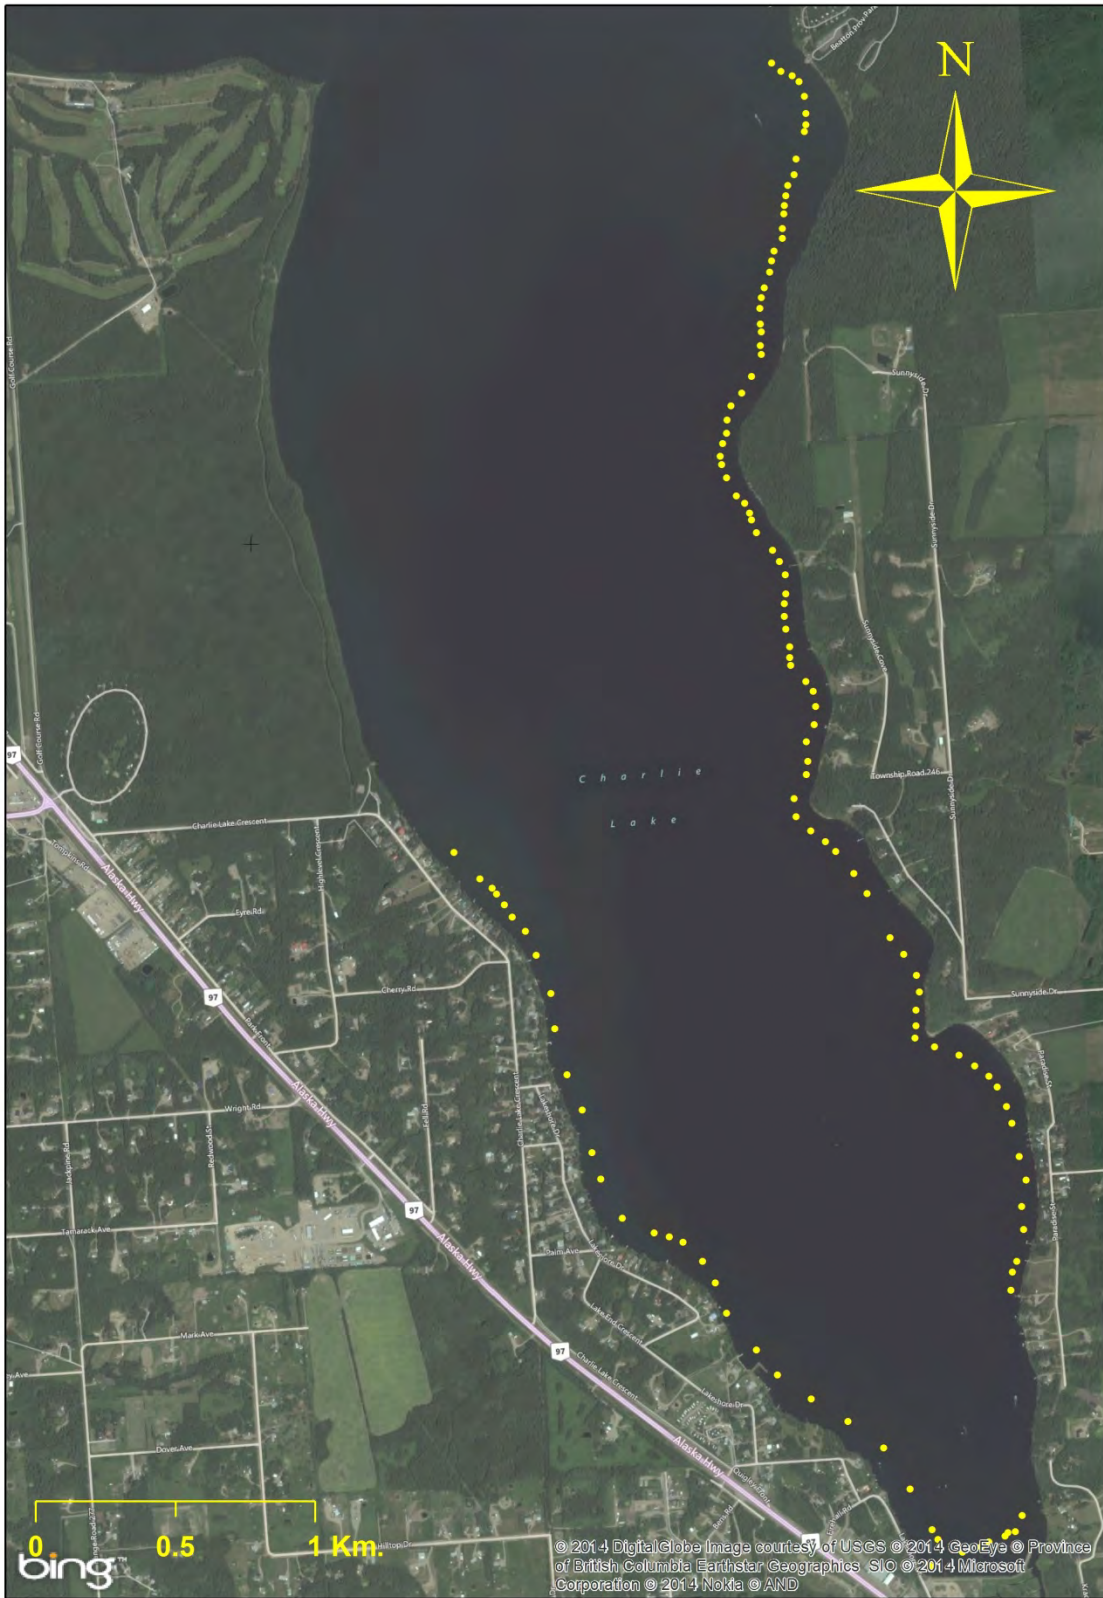
Figure 2: South end of lake.

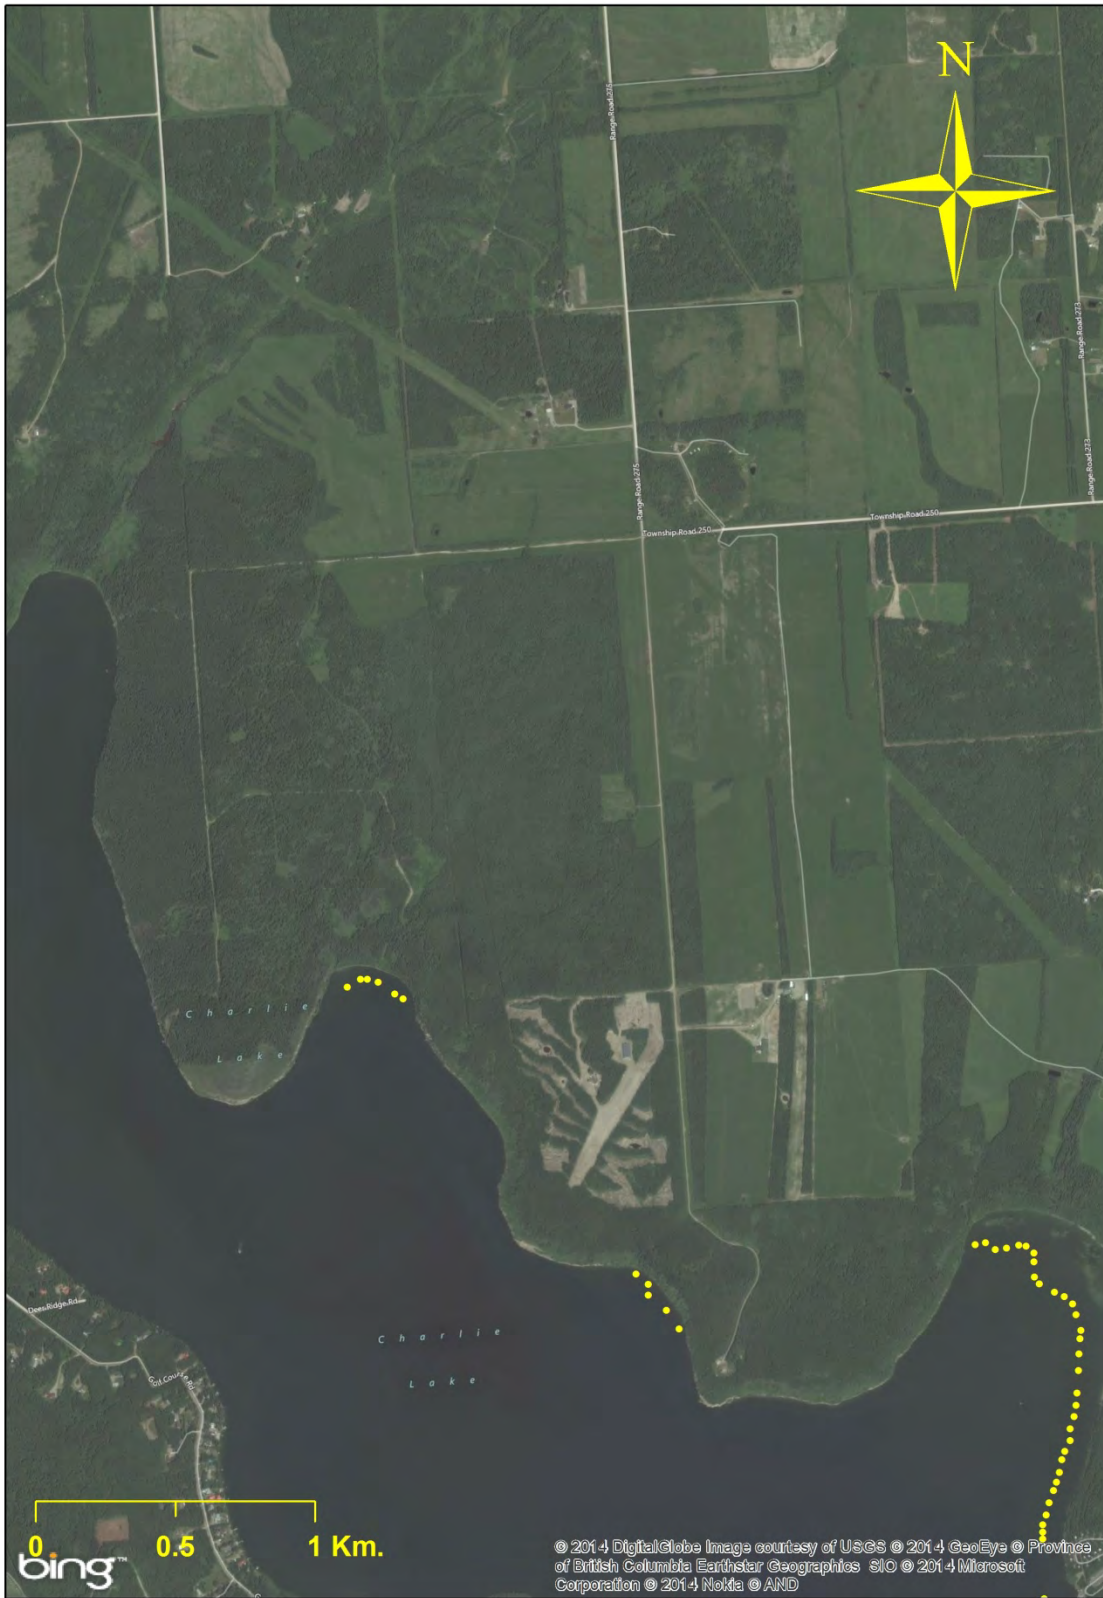
Figure 3: Mid-section of lake.

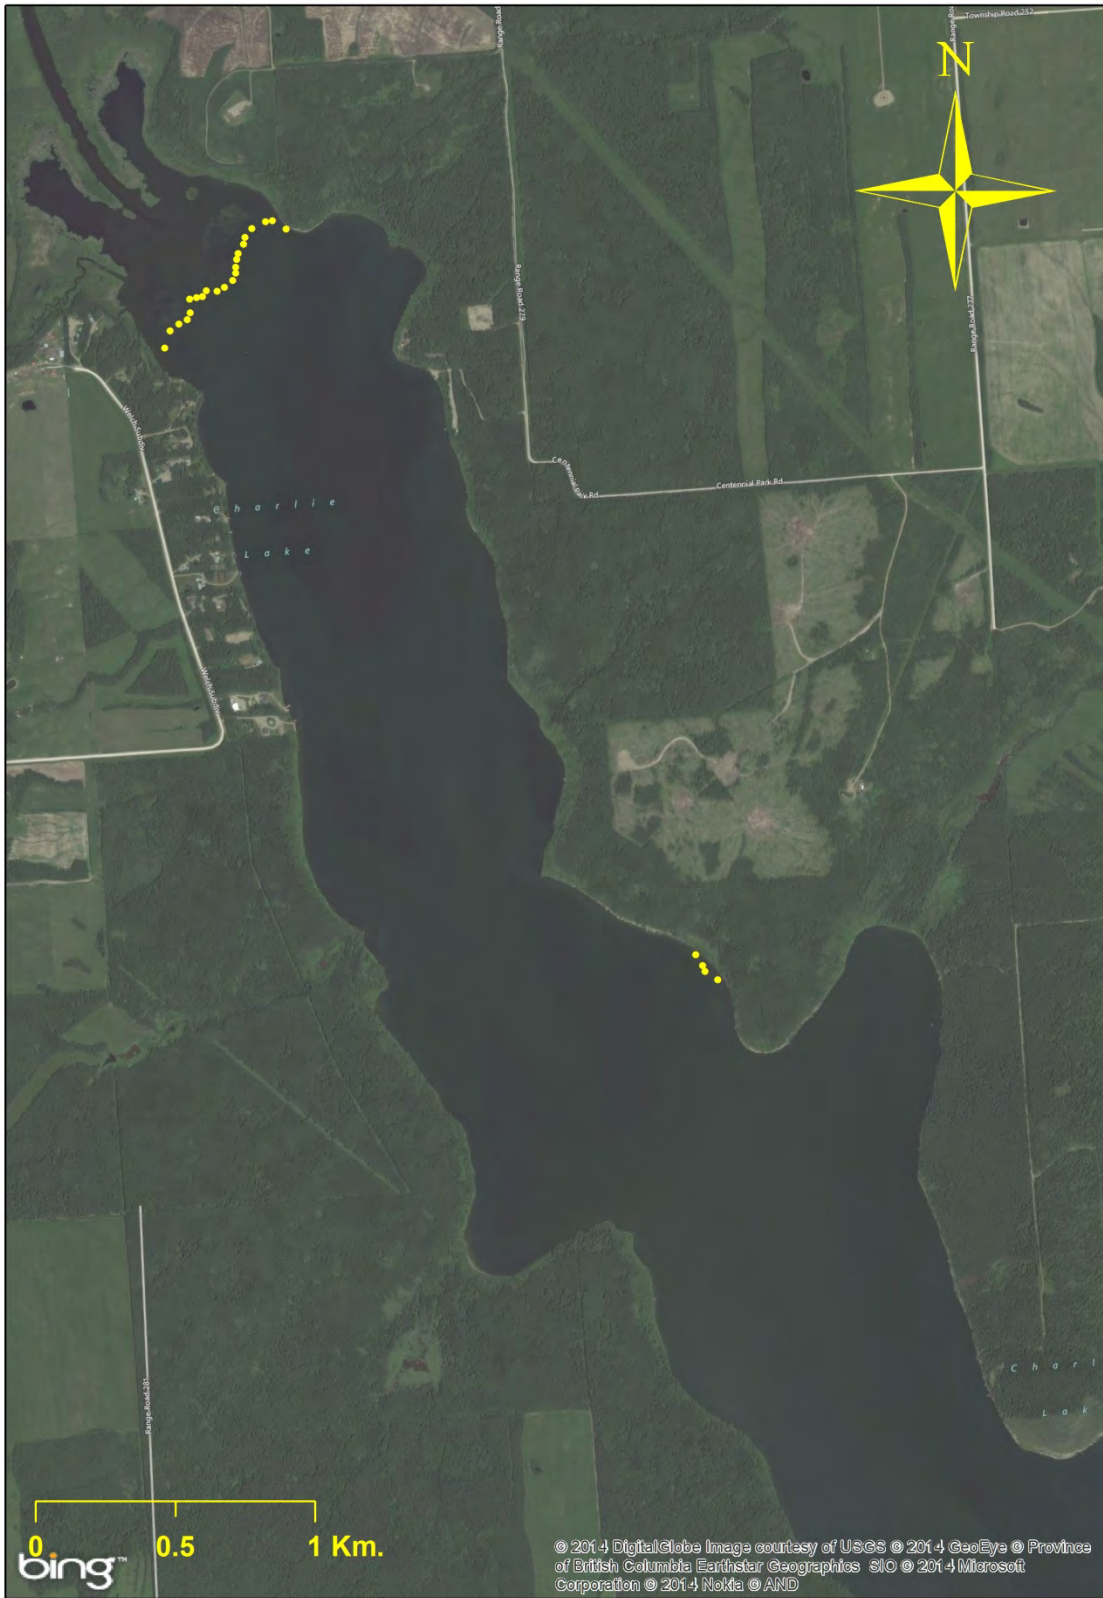
Figure 4: North section of lake.

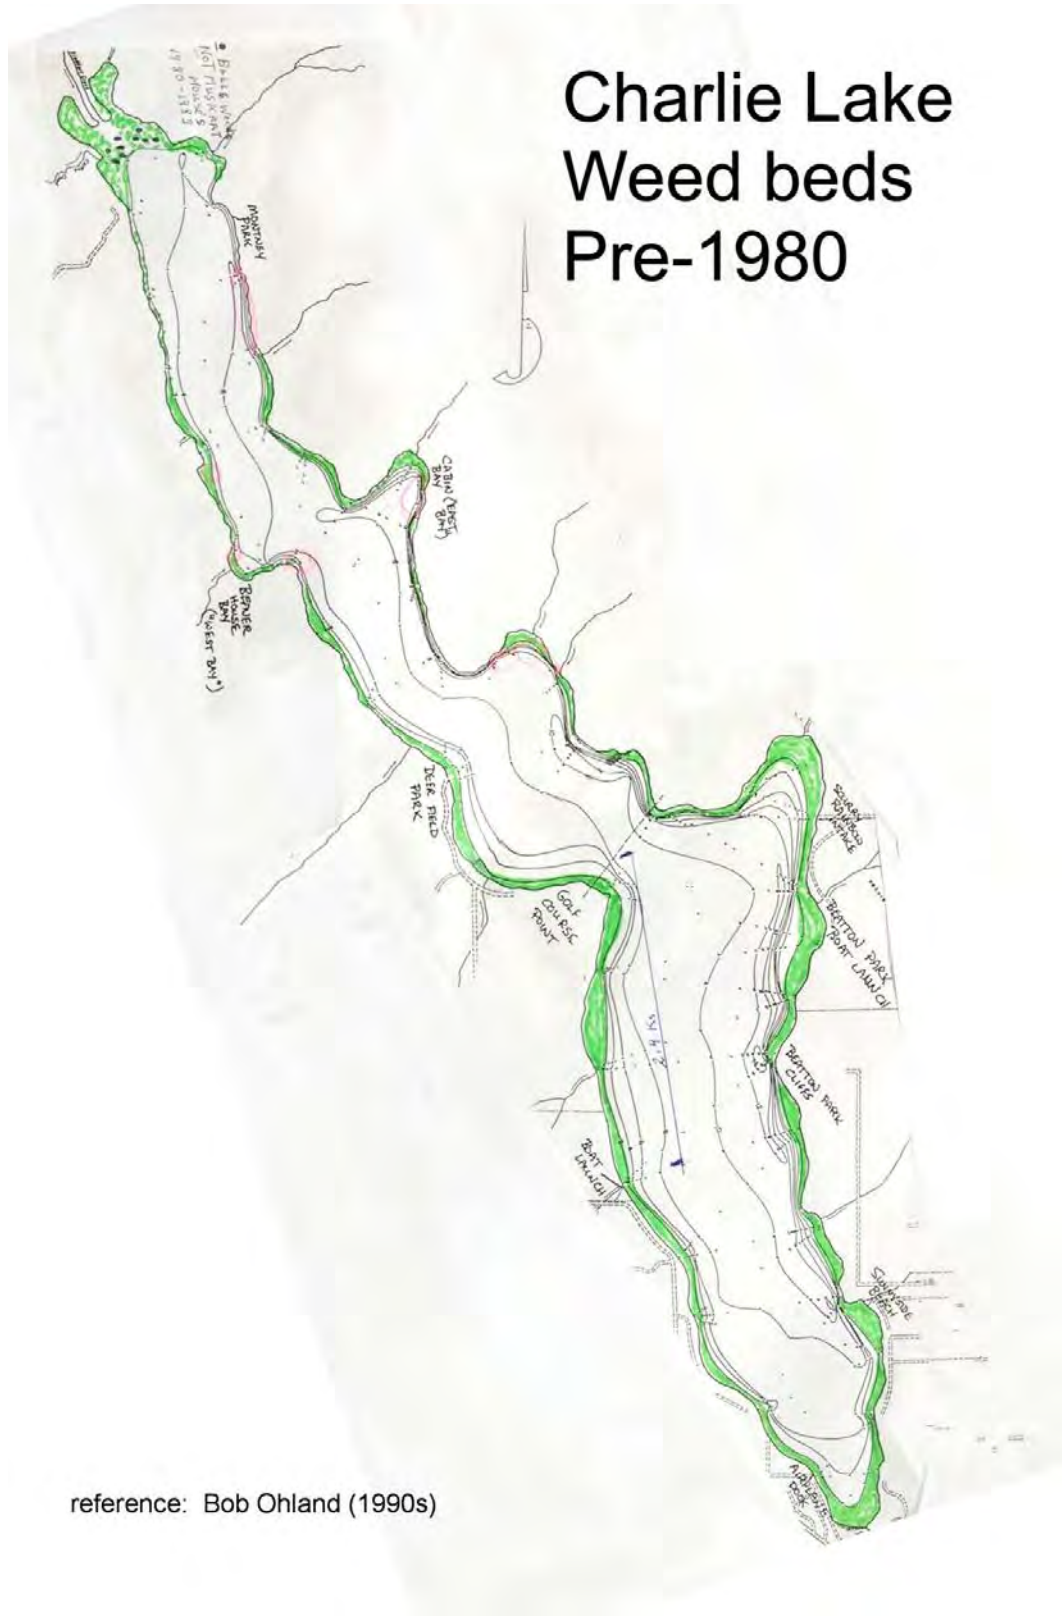
Figure 5: Pre-1980 aquatic plants distribution as mapped by Bob Ohland.

is shown in Figure 5. However, there is no documentation on how the data was collected, so a direct comparison with our data is difficult, but it does provide some context for the many complaints we had received at the Ministry office in the mid-1990's that aquatic plant density was lower than in the 1980's. Currently, people are reporting that densities of aquatic plants are much higher than the past. The wide range of observation reported by the public, with no supporting evidence, reinforces the need for people to get involved in organized observation and data collection, as promoted by the Charlie Lake Conservation Society and the Provincial Ministries. Two examples of such programs are the recording of dates associated with beginning and end of ice cover in Charlie Lake, and water quality sampling, both delivered by members of the CLCS.

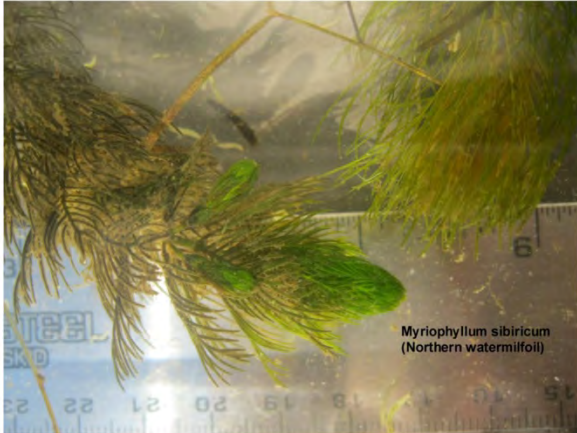
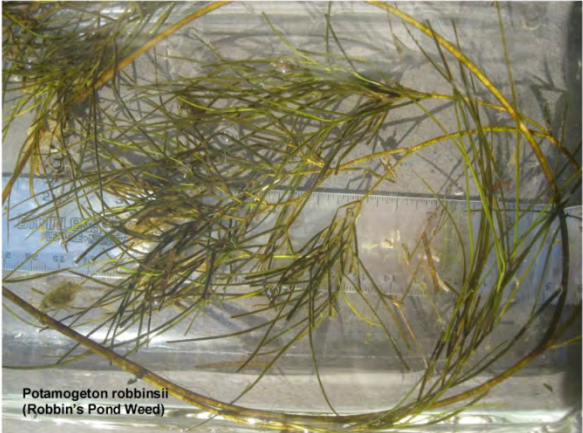
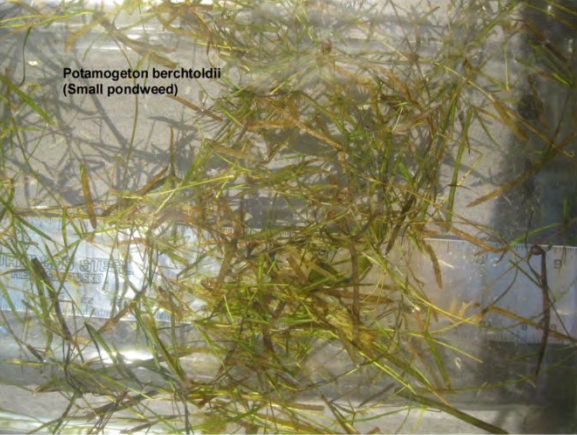
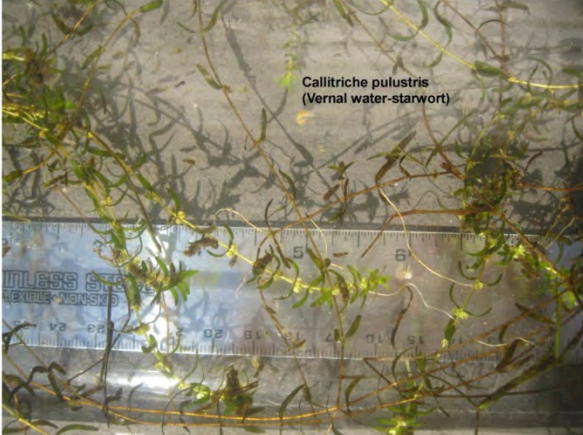
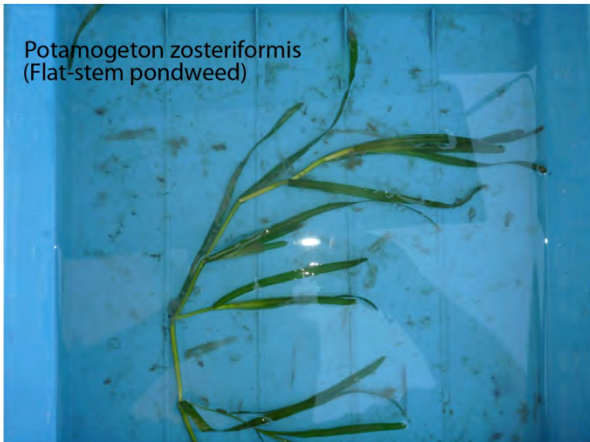
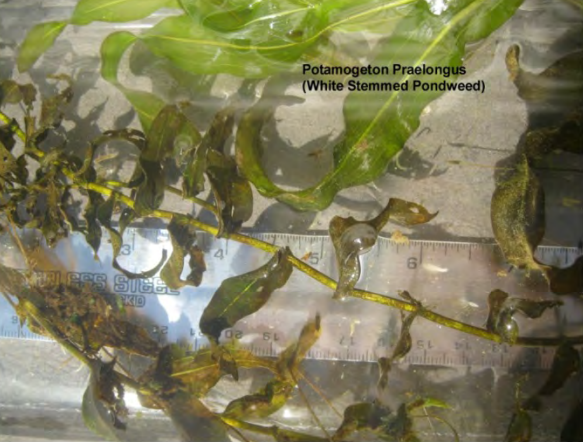
Figure 6: Samples of aquatic plants from Charlie Lake.

All of these are native to the area, and there were no invasive plants identified. Photos of these plants are shown in Figure 6. The most abundant species of plant we observed appears to be the White Stemmed Pondweed, but Northern Water milfoil was also abundant in certain locations.

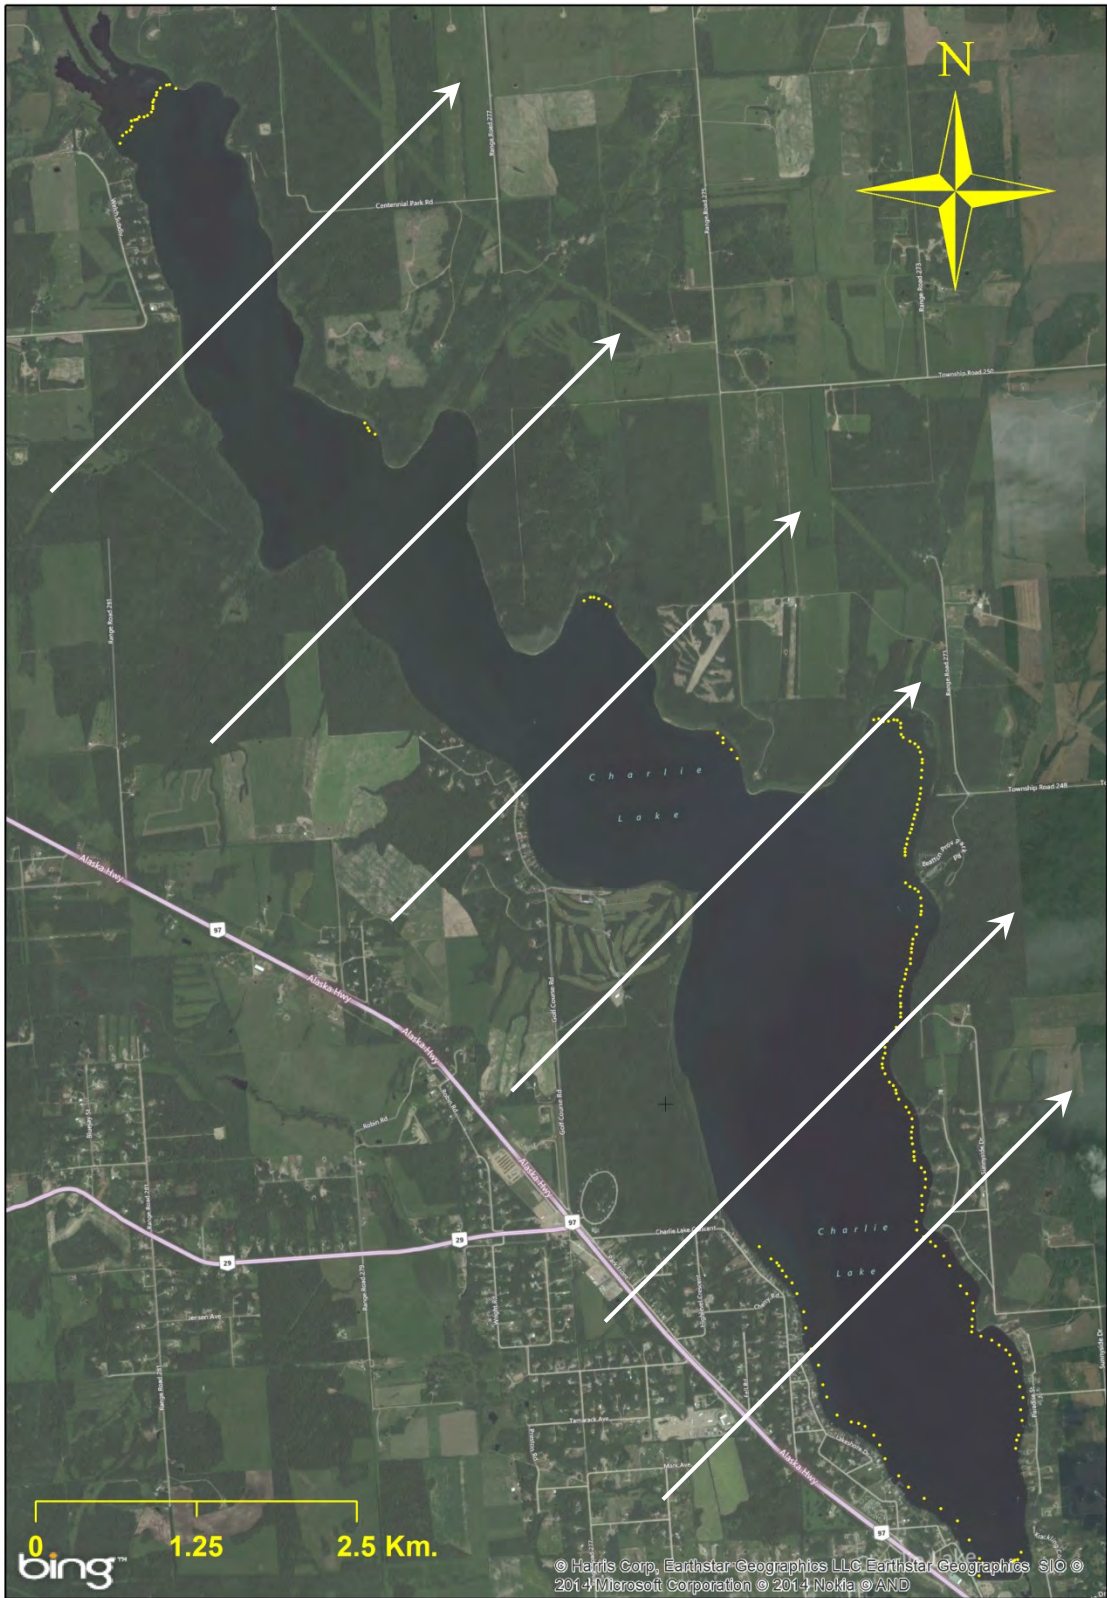
Figure 7: Direction of prevailing winds based on historical weather data.

When we superimpose lines showing the direction of the prevalent winds onto a map of Charlie Lake, it's apparent that the fetch, which is the distance that the wind blows across the water, is greater in the southern half of the lake, compared to the northern half. In the southern half, most of the fetch is greater than 1 km (average = 2.7 km), while in the northern half most of the fetch is approximately 1 km. Or less (average = 1.1 km.).

The aspect of the two halves of the lake may also magnify the effect of the prevailing winds. The southern half of the lake is aligned approximately along a North-South axis, while the northern half lies along a Northwest axis. This would reduce the fetch from the prevailing winds.

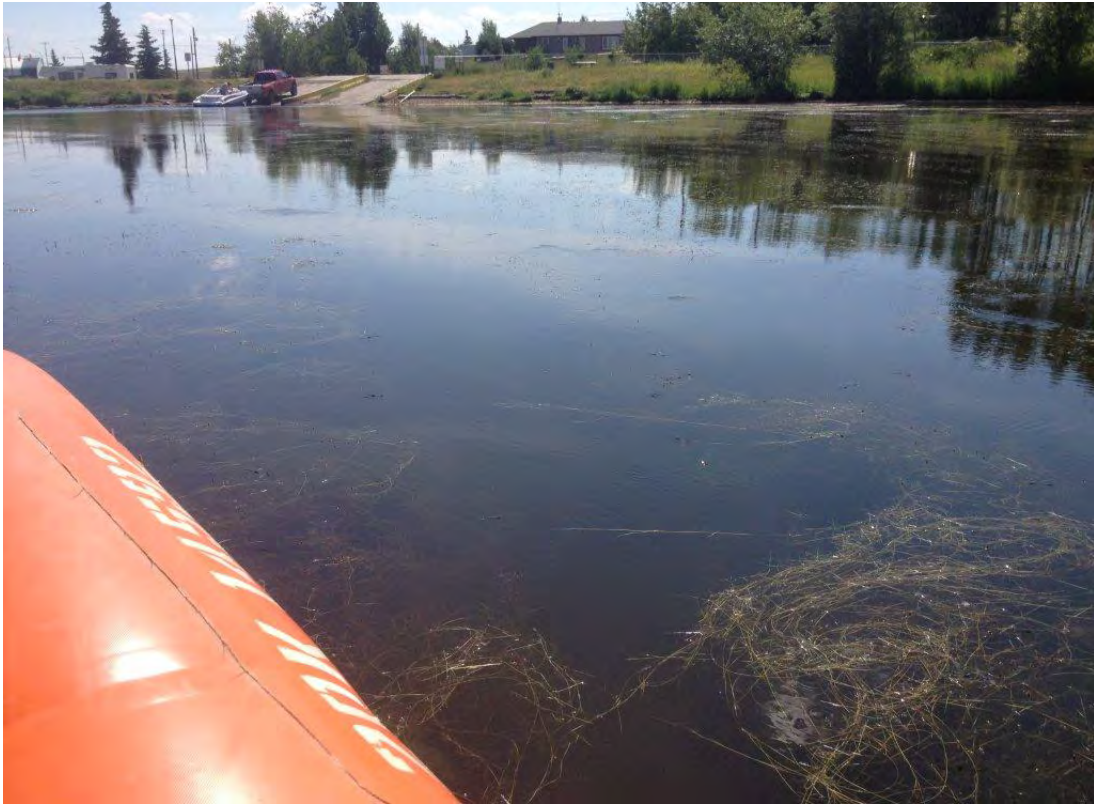
**Figure 8: Aquatic plants near the south end boat launch.**

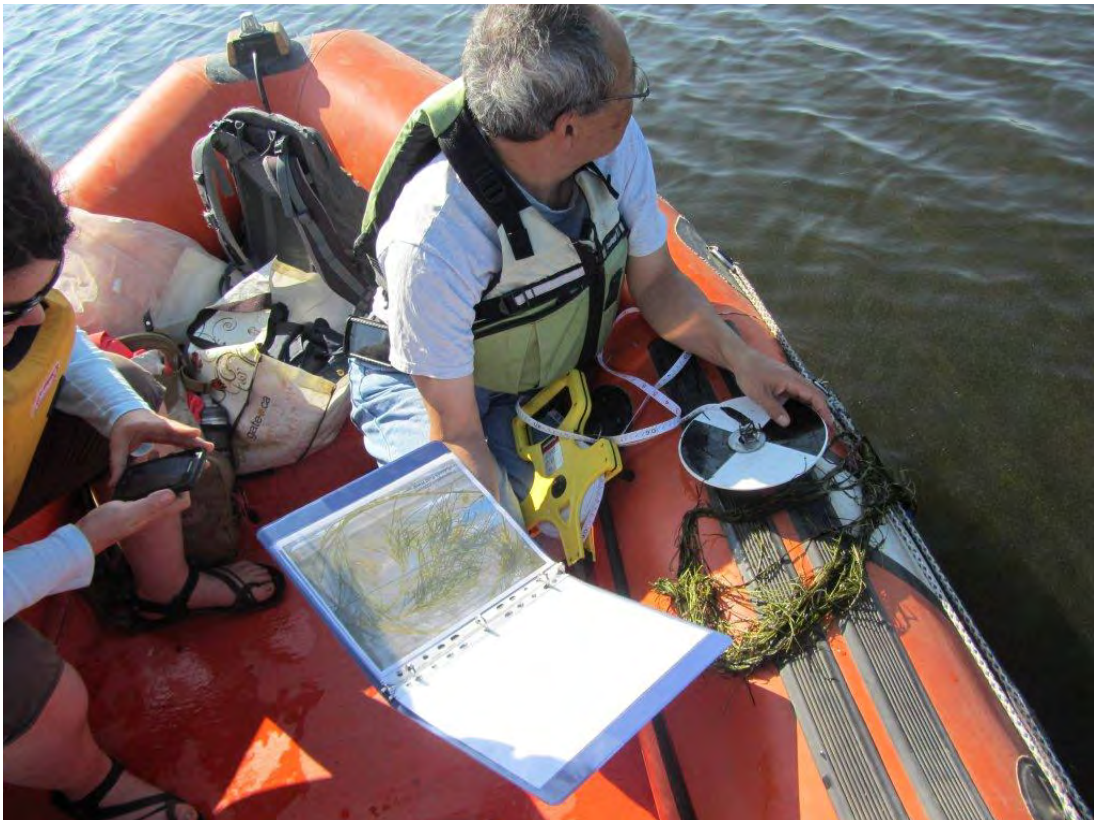
**Figure 9: Bruce about to take a Secchi Disc reading to measure water clarity.**
