# A Long-Term Strategic Plan for the Improvement of Water Quality in the Charlie Lake Watershed

Todd D. French<sup>1</sup> & Barry P. Booth<sup>2</sup>

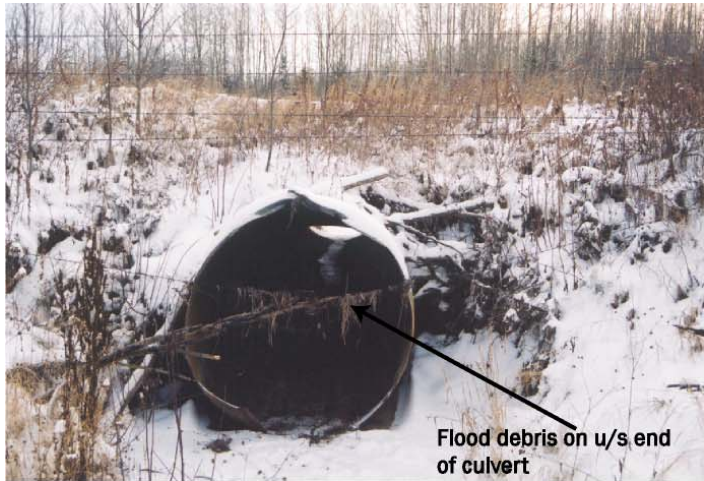
Plate 12. View of culvert inlet upstream of road. Note the flood debris hanging on the fence wire that crosses the culvert (indicates periodic high flows). Also note the slumping behind the culvert (evidence that accumulating water is saturating banks) (November 11/2002).

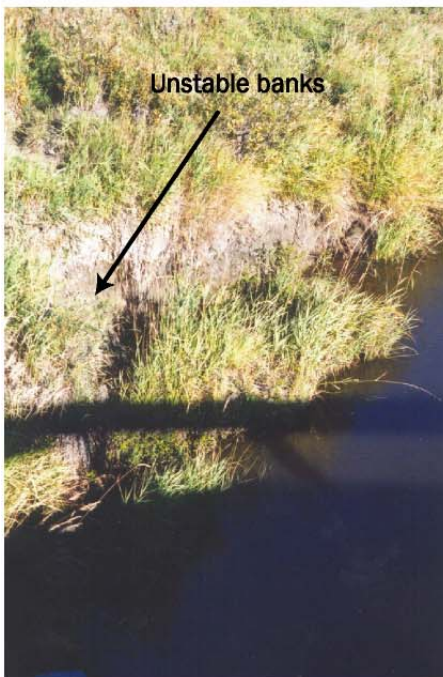
Plate 20. Grasses downstream of road are helping to reduced erosion, but rooting systems are not deep enough to completely eliminate slumping caused by soil saturation. Ideally, the riparian community would be composed of a community of both shrubs and grasses (September 17/2002).

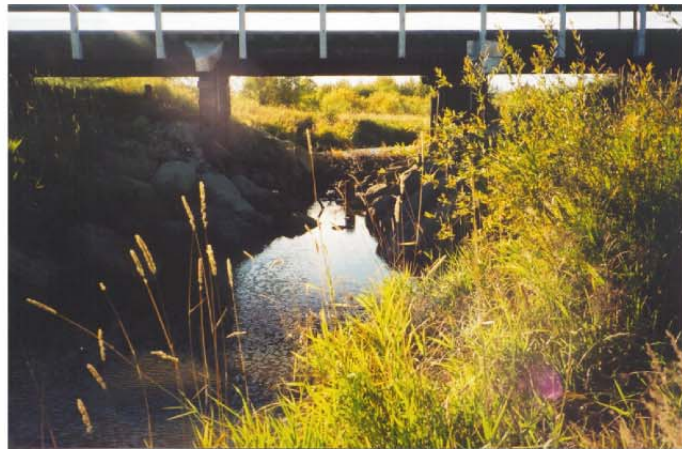
Plate 21. View downstream of road looking upstream (September 17/2002).

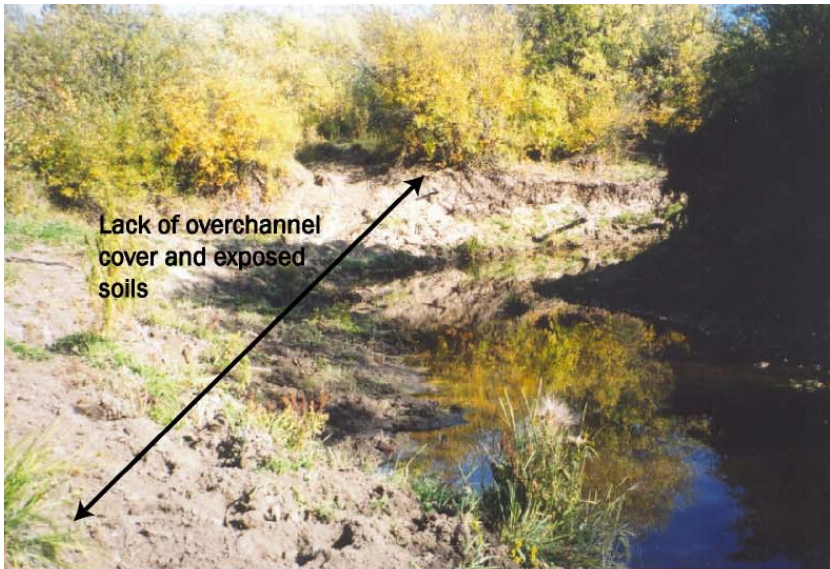
Plate 26. Exposed riparian soils upstream of road that are contributing sediment to the stream. Evidence indicates that the riparian damage was done by livestock; good potential for restoration (September 17/2002).

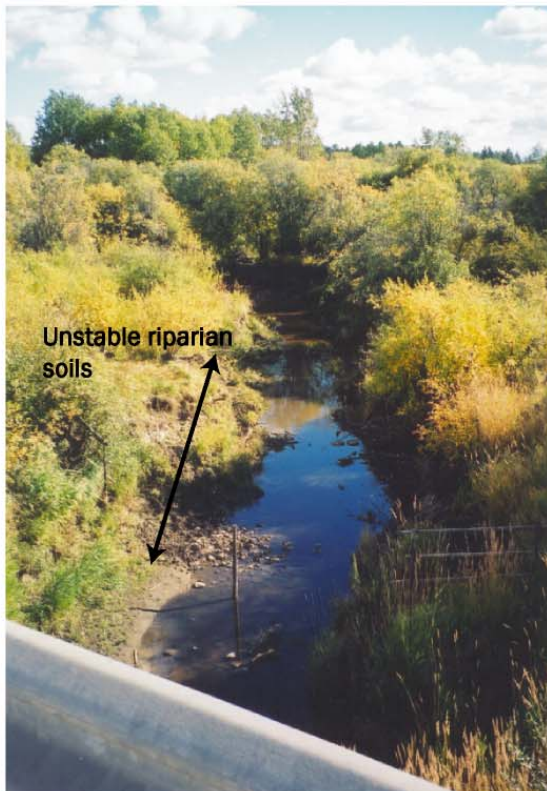
Plate 27. View of channel downstream of bridge. Note that riparian shrubs and grasses are providing protection against soil erosion and substantial over channel cover (September 17/2002).

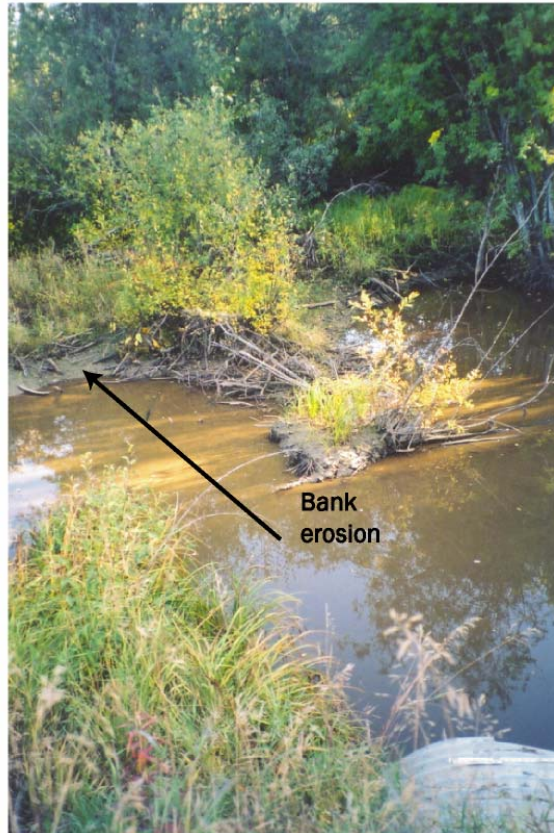
Plate 43. Extreme turbidity downstream of road. Note channel bank erosion (September 16/2002).

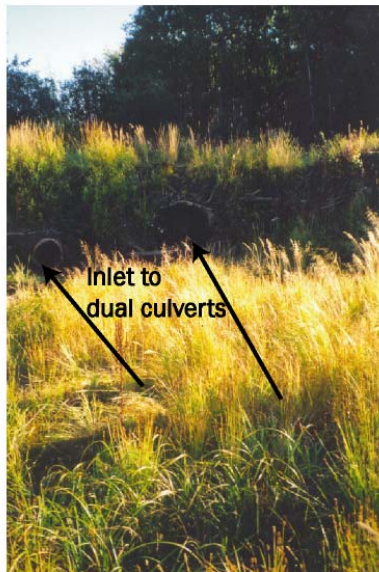
## **CROSSING NO. 11 (DESCRIPTION)**

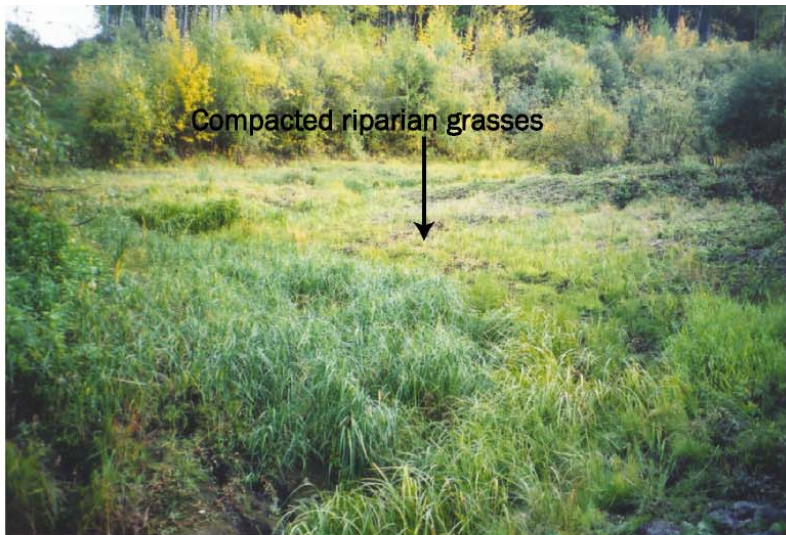
Plate 59. Area immediately upstream of road where livestock have compacted riparian vegetation. Although there is evidence of compaction, the remaining grasses appear to be protecting soils from erosion (very little exposed soil) (September 19/2002).

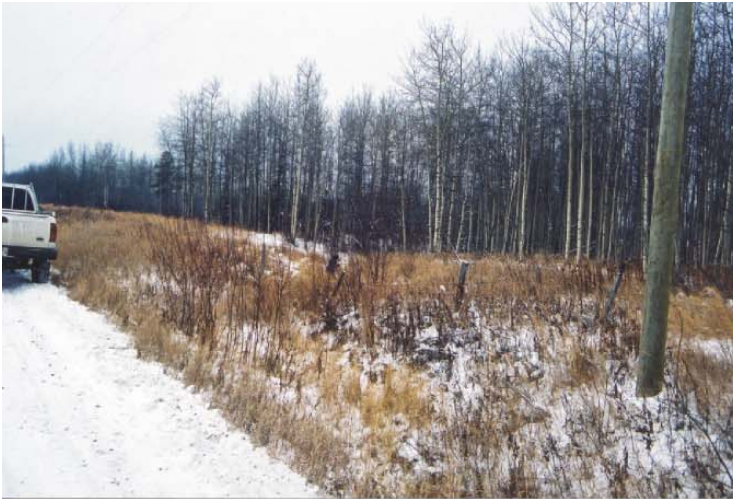
Plate 85. View downstream of the road. Note that the channel is poorly defined (November 12/2003).

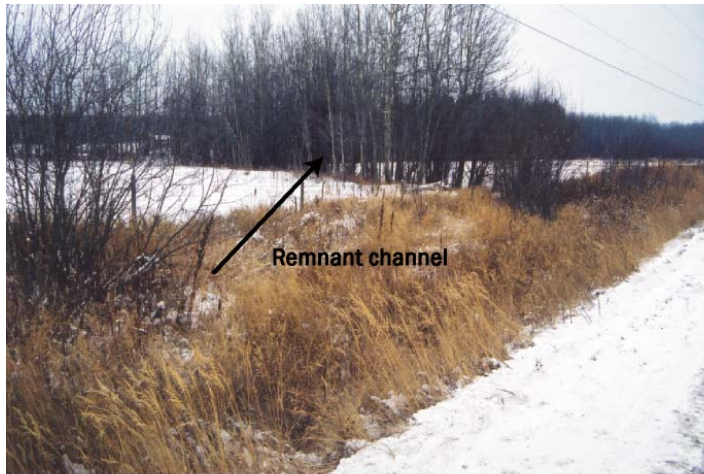
Plate 88. Upstream view of channel. At present, the culvert is draining primarily the ditchline; however, there may be a remnant channel running parallel to treeline in background (November 12/2002).

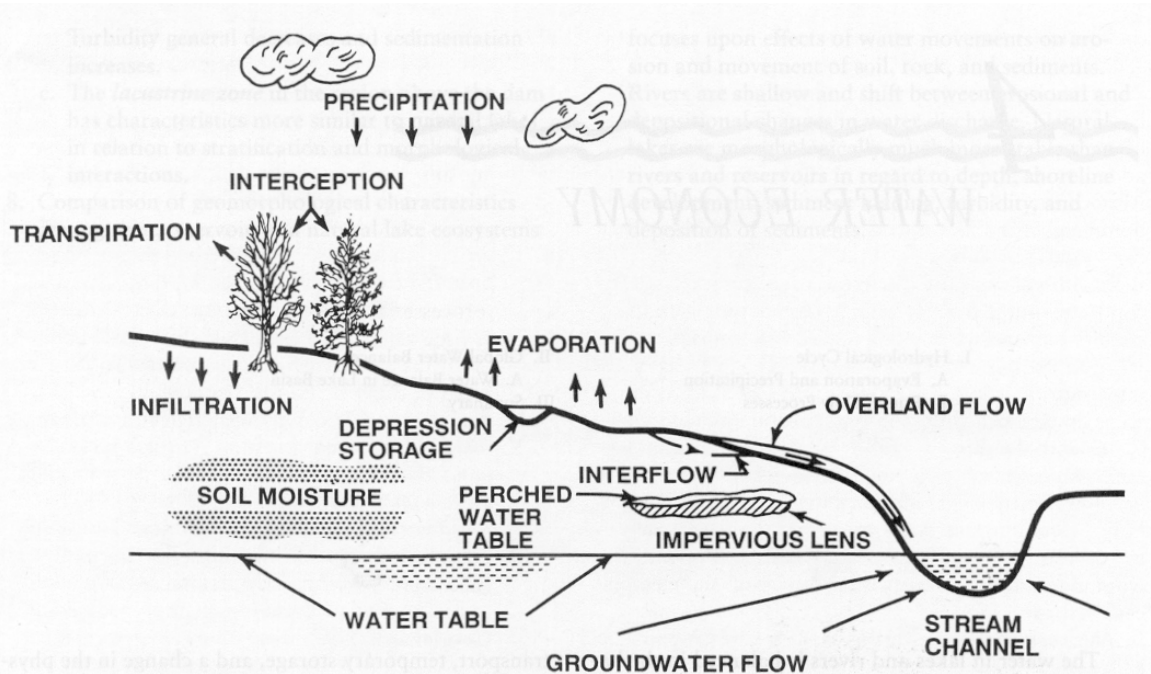
Figure 2. In watersheds where a high proportion of the landscape has been cleared of natural vegetation, water coming into contact with the land tends to move rapidly via overland flow into stream channels, and relatively small volumes recharge sub-surface aquifers (which feed channels with water during summer months in more natural systems (taken directly from Wetzel (2001).

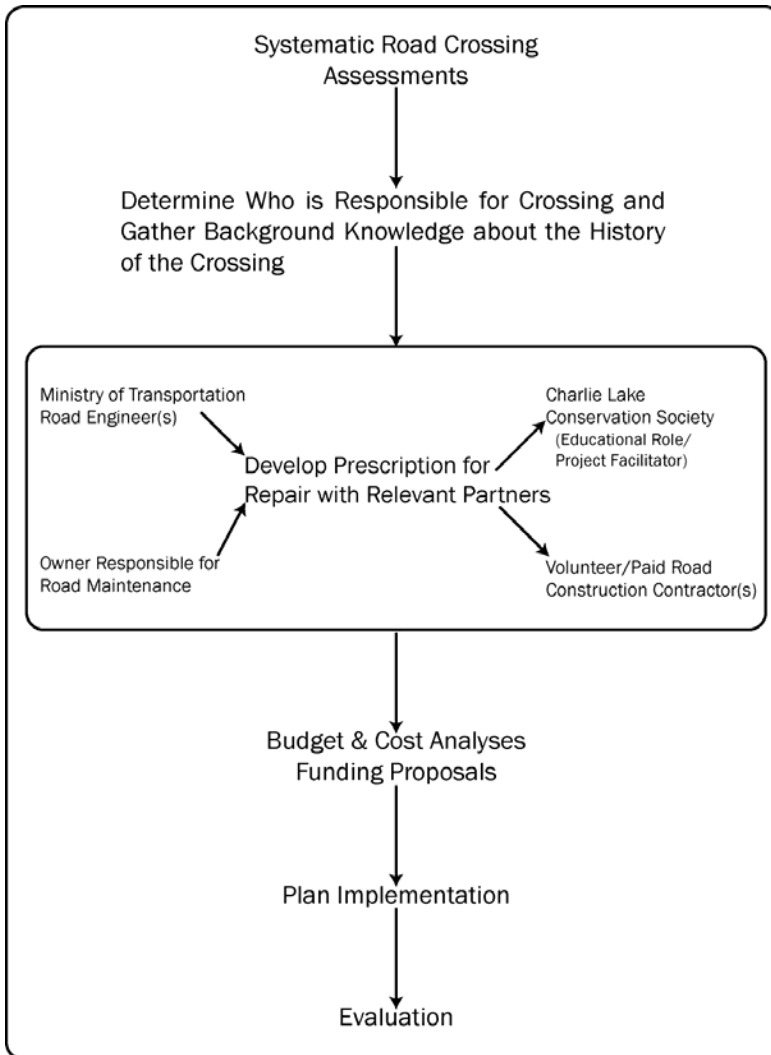
Figure 3. A flow chart for dealing with problematic stream crossings in the Charlie Lake watershed.

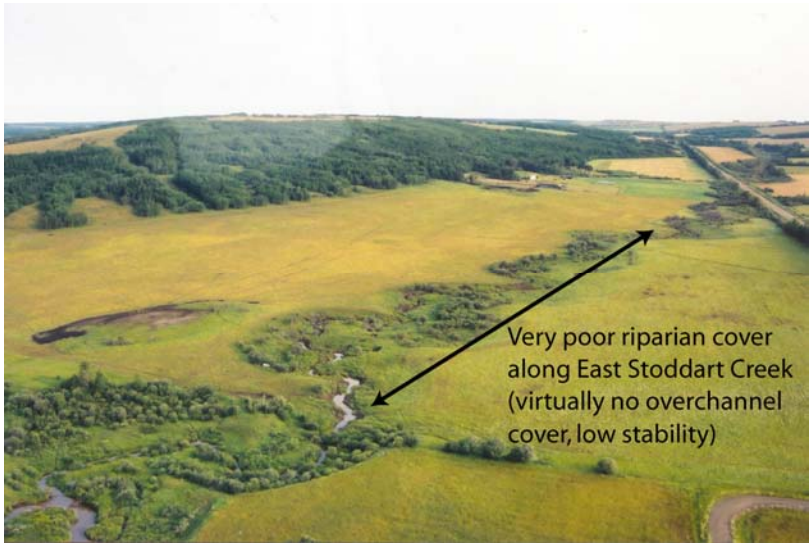
Plate 1. Aerial view of East Stoddart Creek showing reach with poor riparian condition and encroachment of agricultural field.

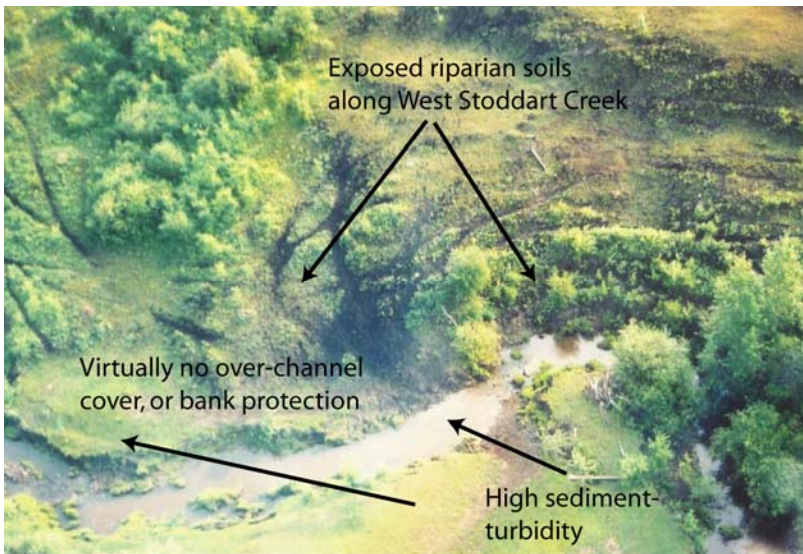
Plate 2. Aerial view of West Stoddart Creek showing poor riparian function and highly erodible exposed soils.

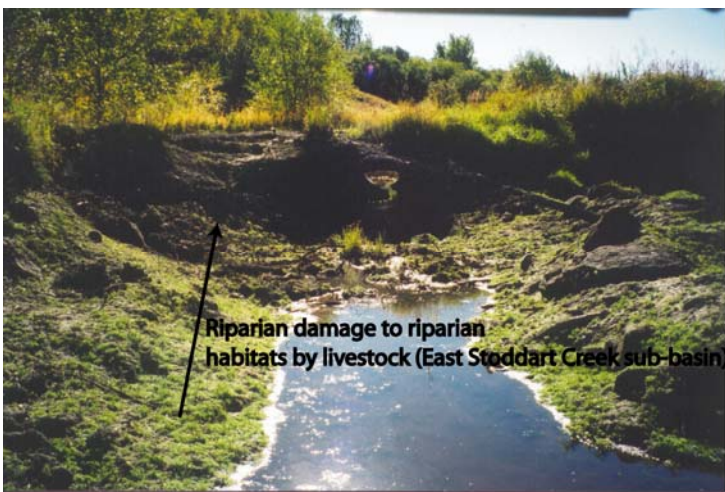
Plate 8. Riparian damage along East Stoddart Creek resulting from livestock access.

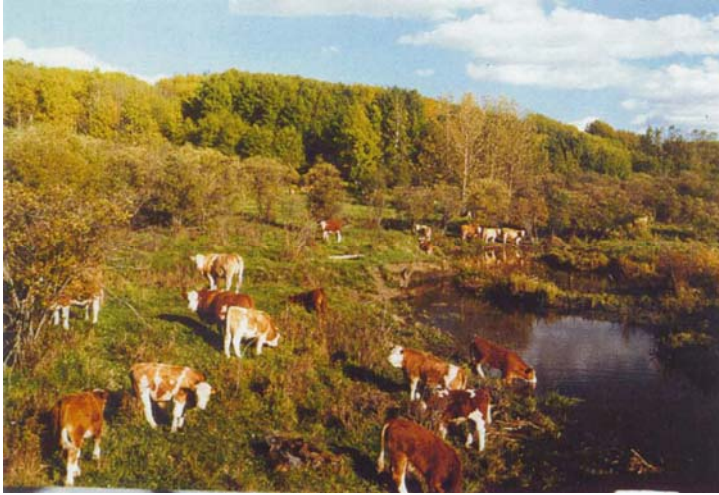
Plate 9. Livestock access to riparian habitats in Stoddart Creek sub-basin.

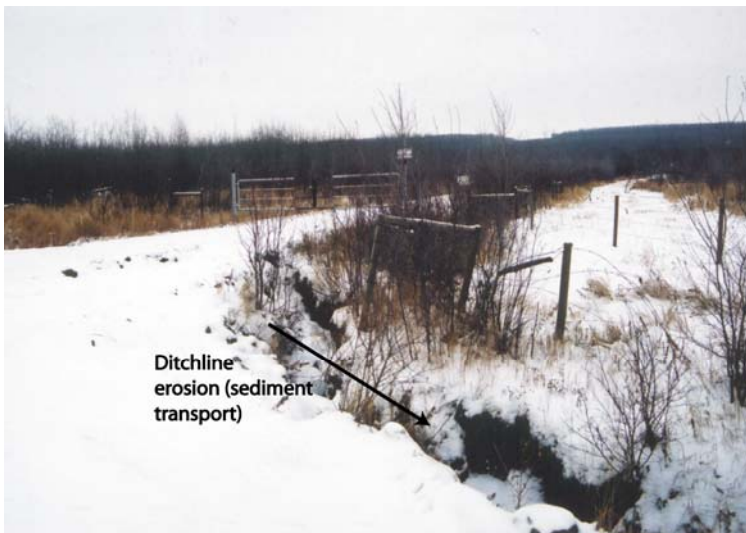
Plate 15. Ditchline erosion observed on private oil and gas road. Ditchline erosion is a common occurrence in the Charlie Lake watershed, particularly where there is any sort of slope (fine sediment is highly erodable, and likely contributes to stream channel sediment loads).

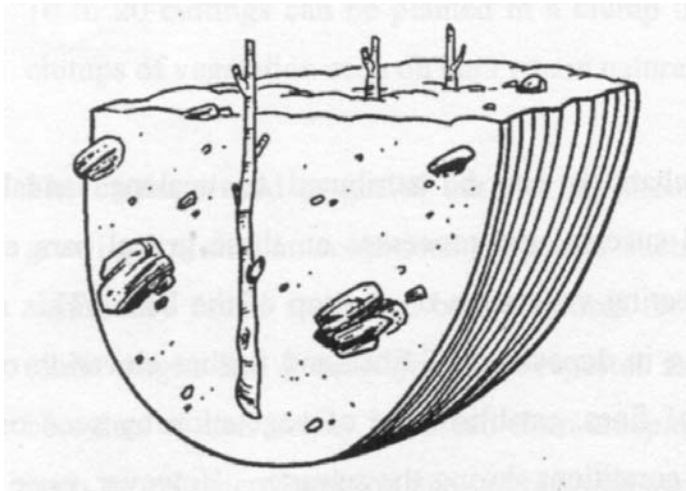
Figure 17. Schematic illustrating concept of live staking (from Polster, 2001).

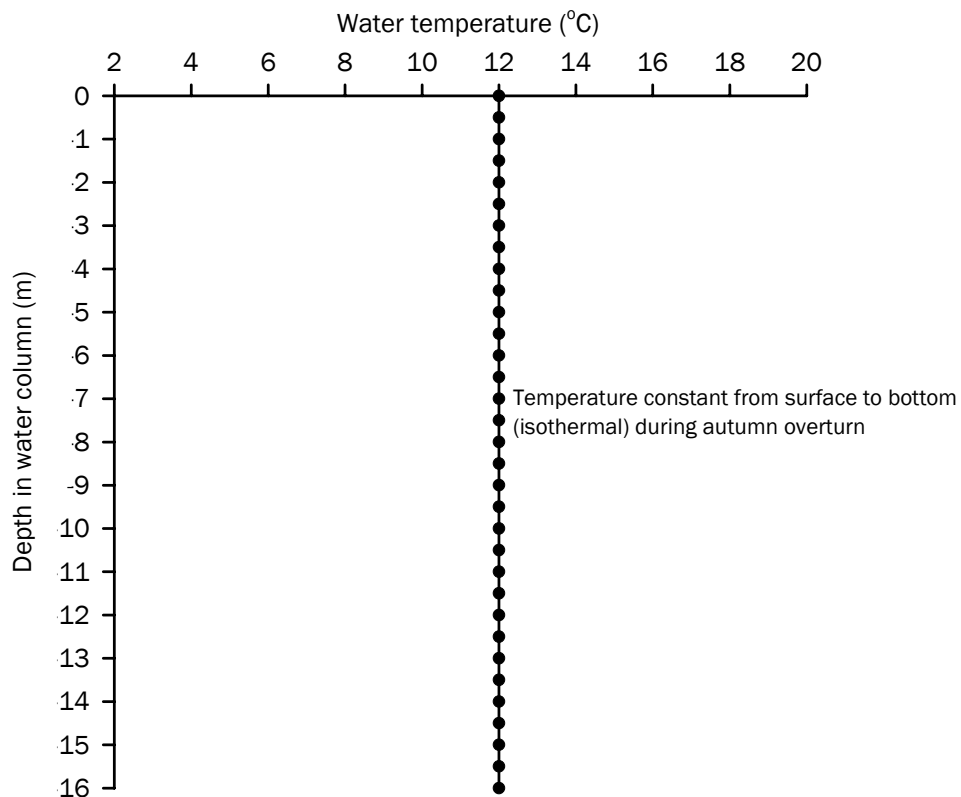
**Bacillariophyte** - are a division of algae commonly referred to as “diatoms”. *Bacillariophytes* have the photosynthetic pigments chlorophyll *a* and chlorophyll *c*. They do not have flagella; thus, they are not mobile (they move with water currents). They are unicellular (single celled) organisms, but some species are colonial (several individual cells living attached to each other). They live in “glass houses” that are composed mostly of silica dioxide (SiO<sub>2</sub>). These glass houses are known as “frustules” and form sedimentary deposits/soils known as diatomaceous earth (the remains of dead Bacillariophytes). See also *Diatom, Photosynthesis, Algae, Chlorophyll, Silica, Frustule, Flagella*.

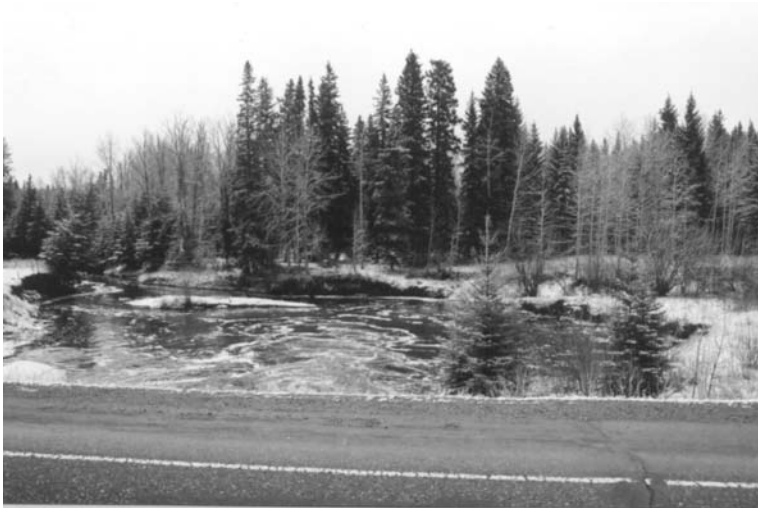
Massive scour hole downstream of a highway in the Dawson Creek, British Columbia area (Tupper Creek).

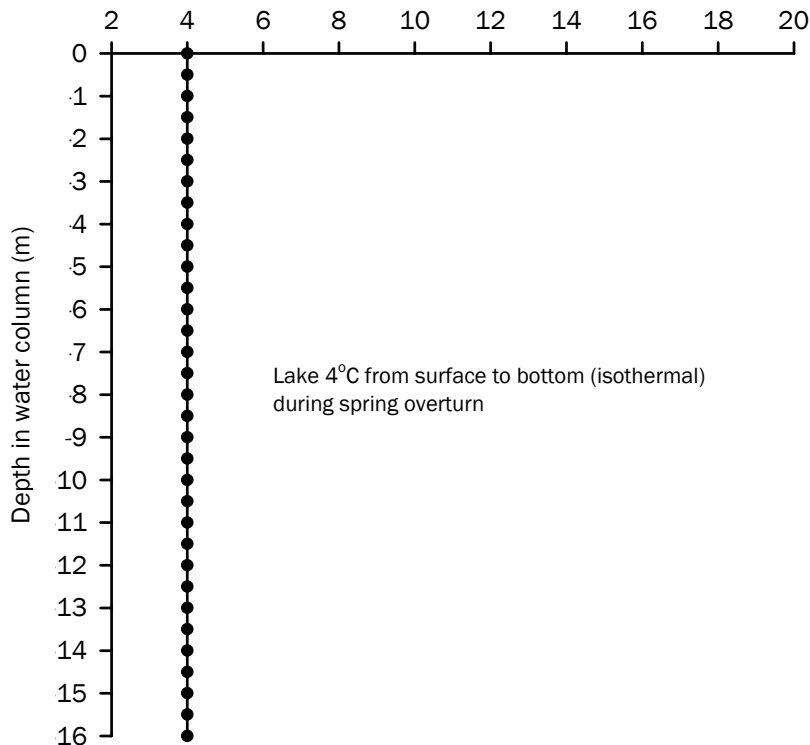
**Substrate** – in general, refers to a surface that organisms grow on. For example, the *substrate* for epiphytic algae is large plants, the *substrate* for epilithic algae is rock, and the *substrate* for epipelagic algae is sand. See also *Algae, Epiphyte, Epipelagic, Epilithic, Periphyton, Attached algae*.

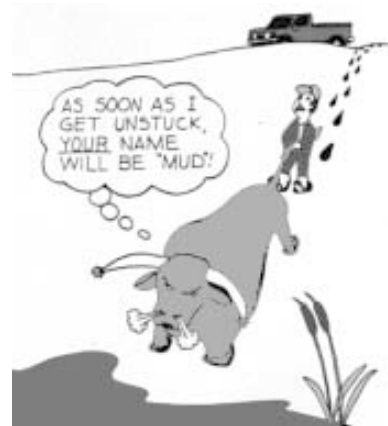
#### Poor pasture utilization:

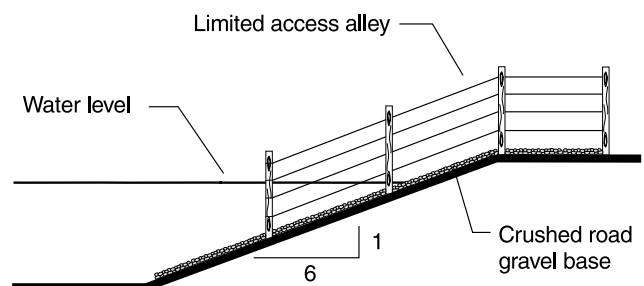
Figure 1a. Cross section view of access ramp

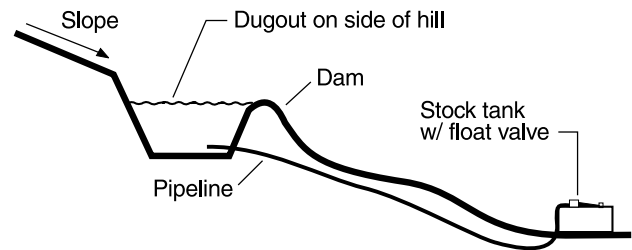
Figure 3. Gravity-fed system

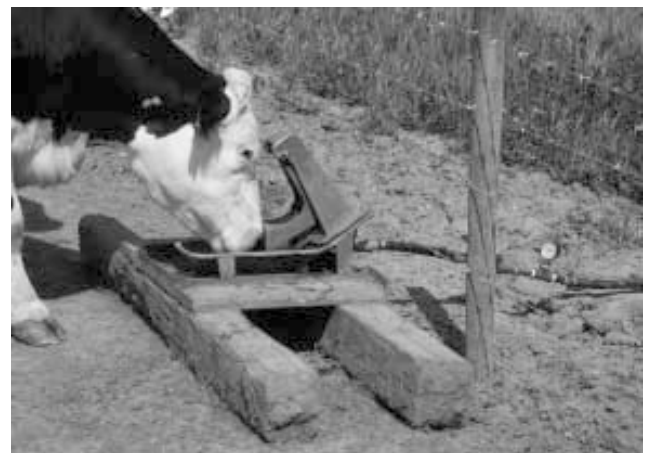
There are five or six types of nose pumps being sold in Alberta. Some of the pumps are slightly easier to push than others. They all supply approximately 1 litre of water for every stroke of the nose device. The pumps can lift water a maximum of 20 vertical feet and, with the use of a shallow buried pipeline, can also be offset a quarter of a mile or more from the water source. Minimizing the amount of elevation lift from the water makes it easier for cows and calves to operate the pump. Shallow burial of the pipeline is recommended once the best locations for the pumps have been determined.

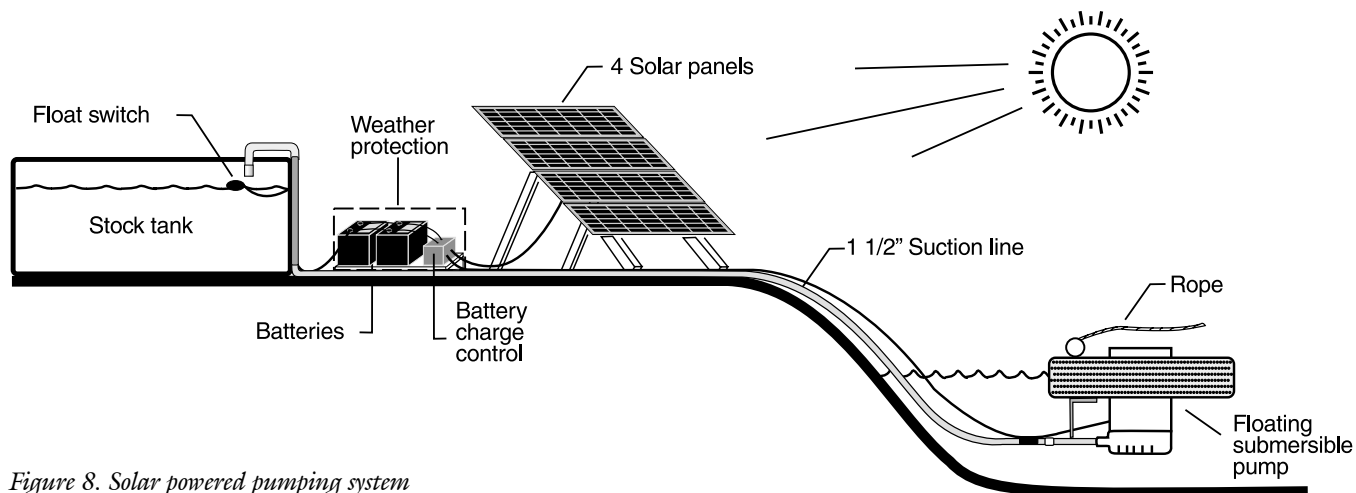
Figure 8. Solar powered pumping system

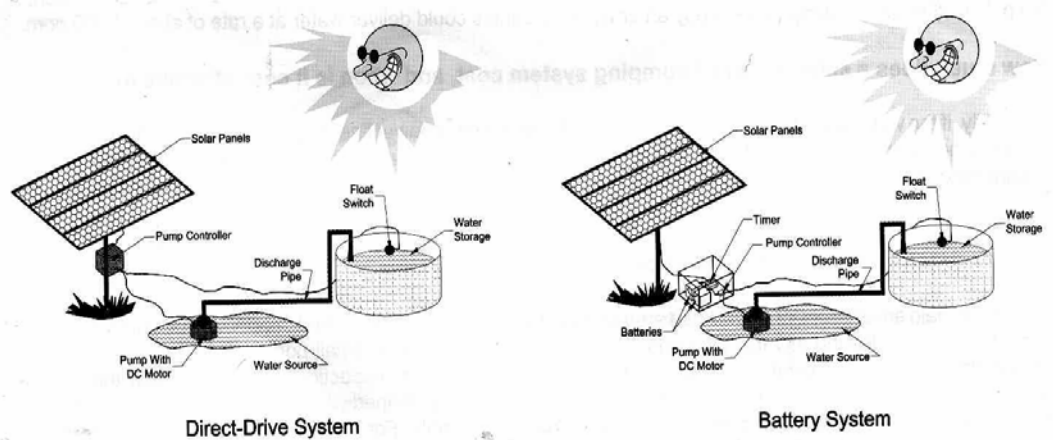
### For more information call:

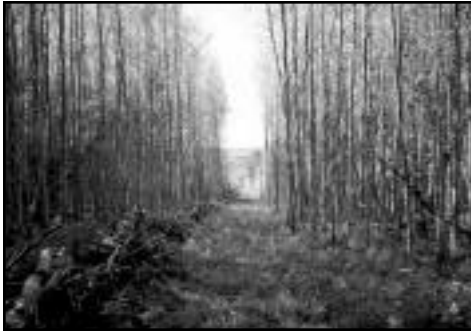
*What are your rights  
as a landowner?*

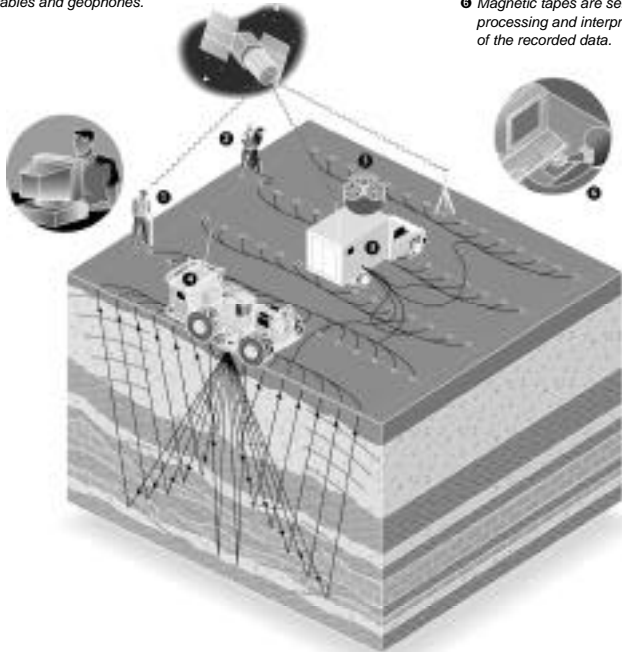
Courtesy of the Petroleum Communication Foundation

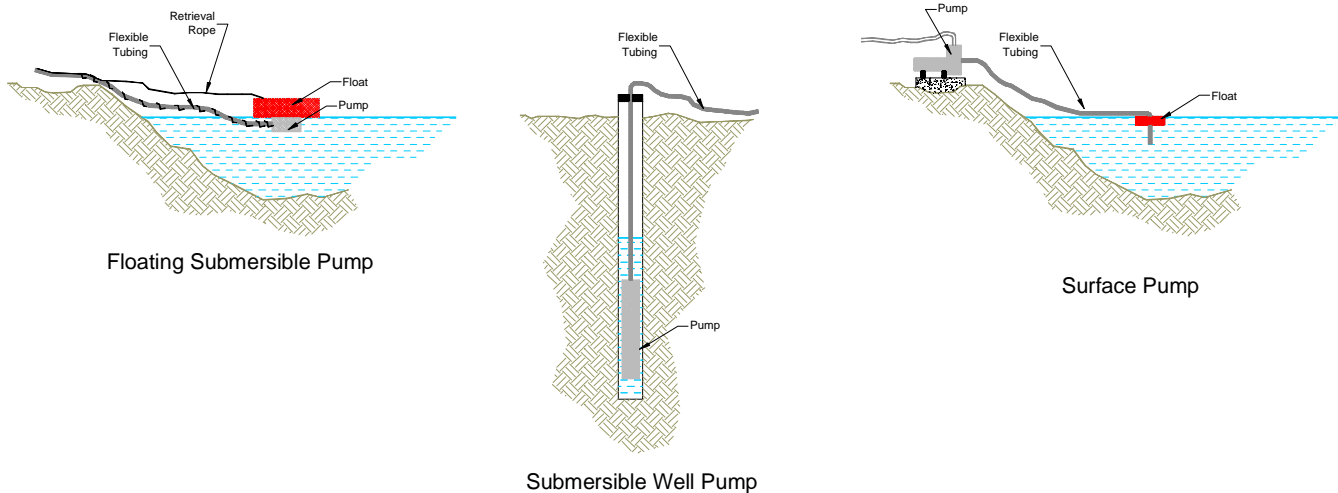
### How much water can a solar-powered pump deliver?

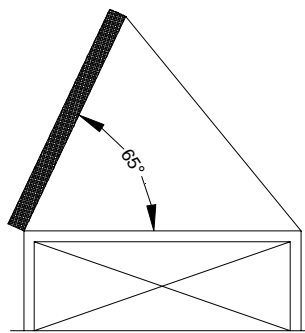
The solar panels should be tilted at an angle to horizontal to maximize power output. If the panel is to be fixed for year-round use, the tilt angle should equal the latitude of the site. If the panel mount has an adjustable tilt angle, the tilt angle should be equivalent to the site latitude minus 10 to 15 degrees in the summer, whereas in winter, the tilt angle should equal the latitude plus 10 to 15 degrees. The following sketches illustrate typical tilt angles for most mid-latitudes on the Canadian Prairies:

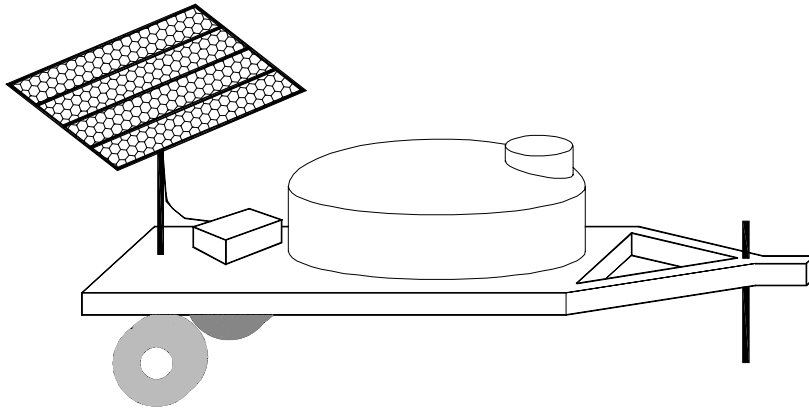
Trailer-Mounted Unit

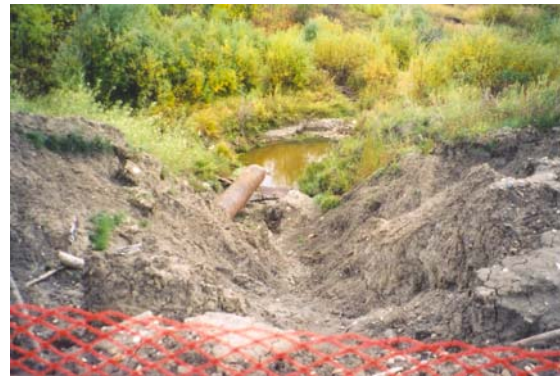
Unstable stream crossings in the Charlie Lake watershed are contributing sediment and sediment-bound nutrient loads to the lake and are thought to be accelerating lake in-filling and eutrophication rates.

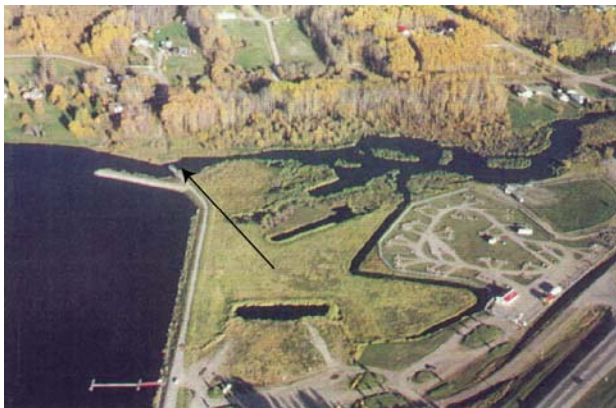
Overhead view of Charlie Lake's outlet (Lower Stoddart Creek, locally known as Fish Creek). The arrow is pointing to the weir that was constructed across the lake outlet. The weir regulates lake levels and has increased the maximum elevation of the lake's surface by about 1 m.

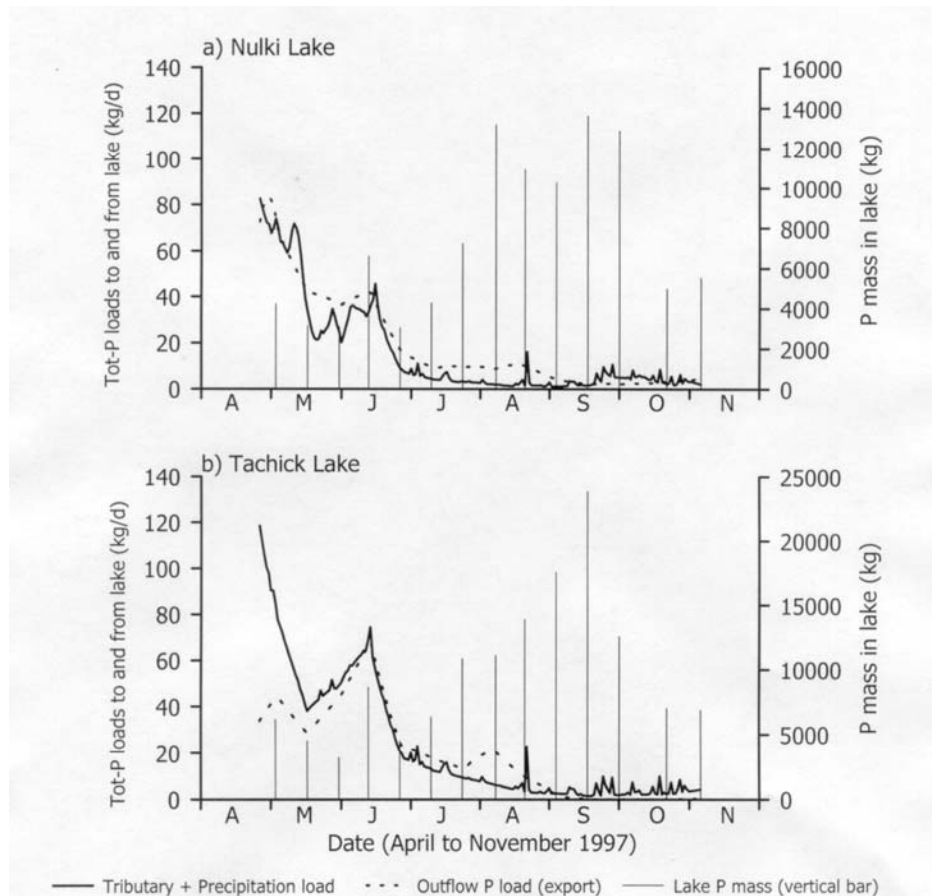
Figure 3. External P loading (tributary + atmospheric) and P export (outlet streams) rates to and from Nulki (panel a) and Tachick (panel b) lakes, and estimated P mass in lakes (vertical bars). External P loading and P export via outlets were approximately equal in August and September when the P mass in the lakes was greatest, suggesting that the observed increase in P mass was the result of internal loading processes.

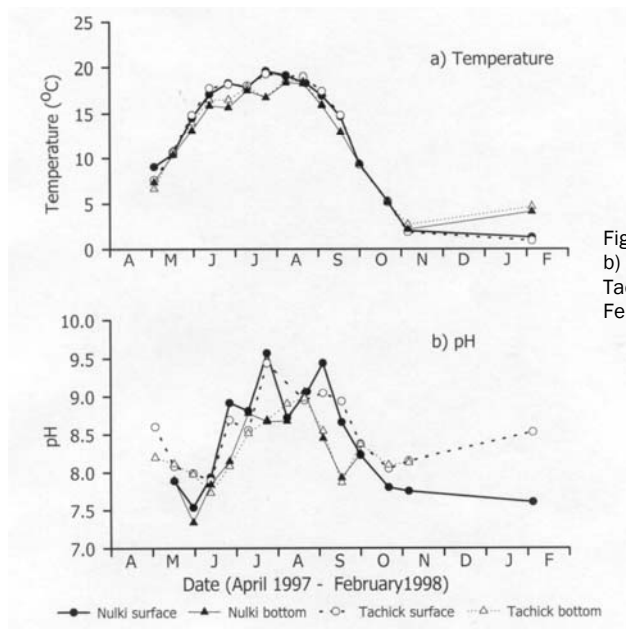
Figure 4. Temperature (panel a) and pH (panel b) of surface and bottom waters in Nulki and Tachick lakes during the period April 1997 to February 1998.

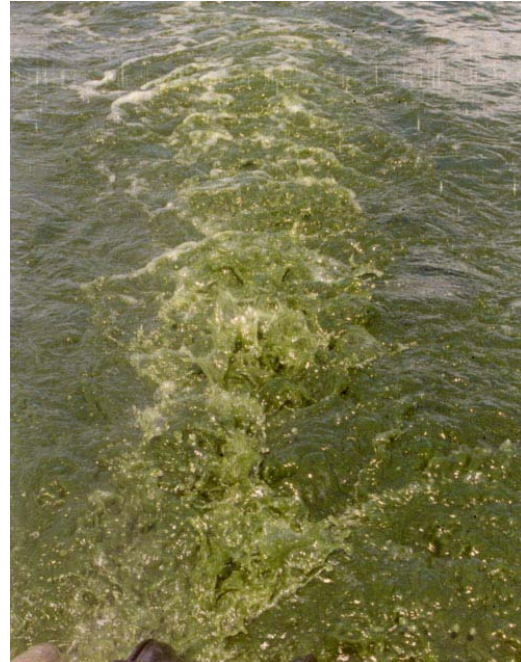
Dense algal bloom observed in Charlie Lake during the late summer/early autumn. Observed turbulence caused by a boat motor.

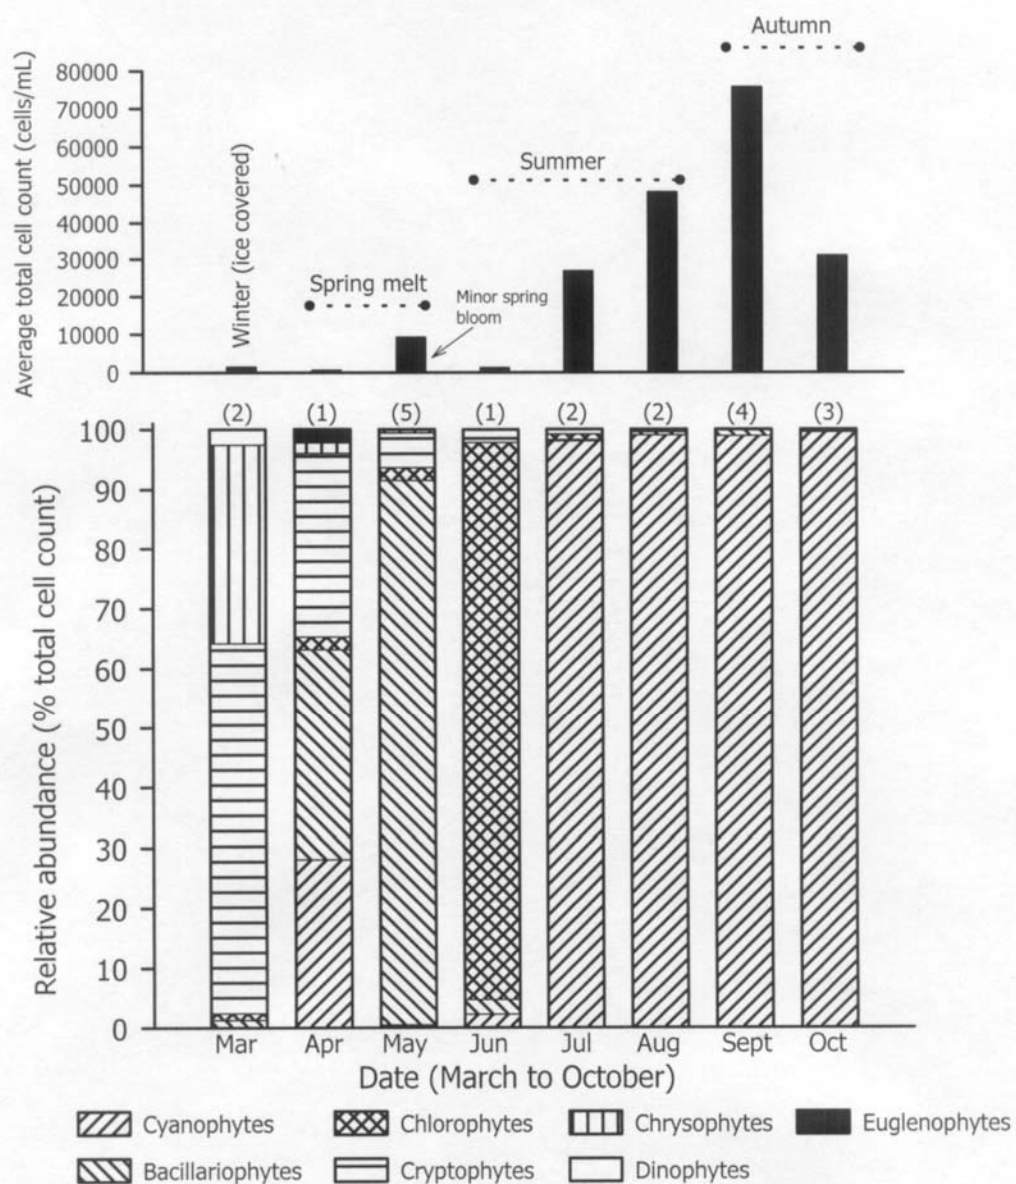
Figure 6. Average total algal cell count (top panel) and taxon-specific relative abundance (bottom panel) observed in Charlie Lake during the period 1984 to 1992. Relative abundance estimates were based on average cell counts observed during a particular month. Bracketed numbers above bars are the total number of observations made during a particular month (for example, data for the month of May was based on five taxonomy samples collected in that month over the period 1984 to 1992).

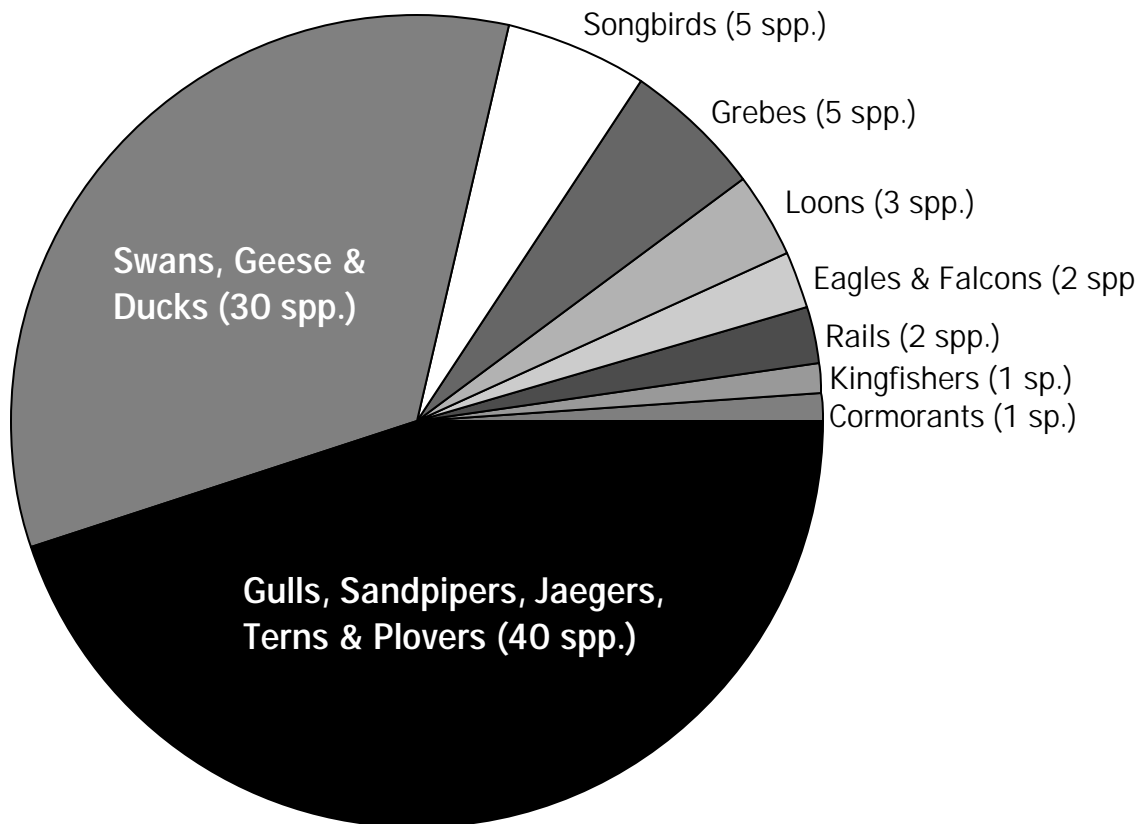
Figure 2. Species richness in each of the taxonomic orders observed during the 1981 to 1988 Charlie Lake bird surveys.

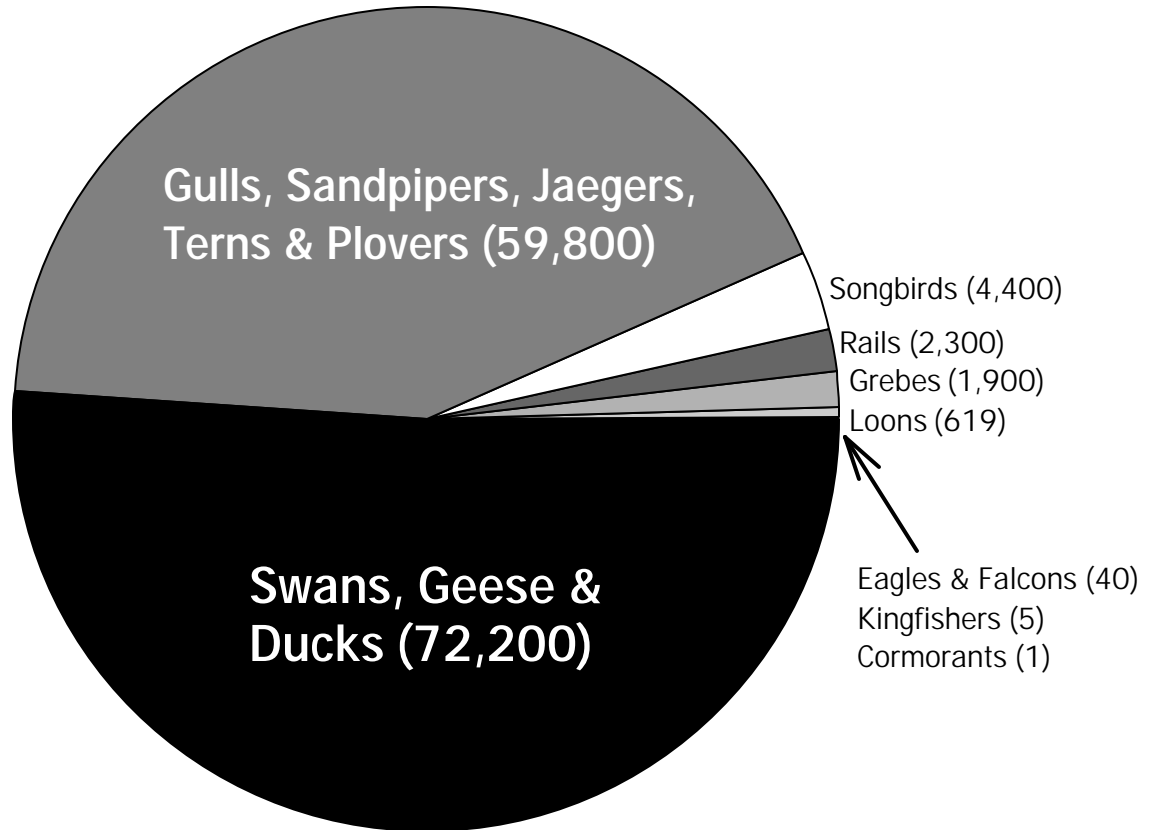
Figure 3. Approximate total number of individuals observed in each taxonomic order during the course of the 1981 to 1988 Charlie Lake bird surveys.
